Utility Conflict Report

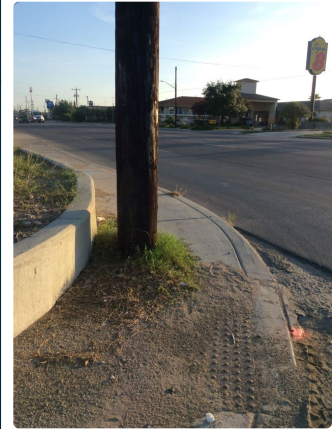
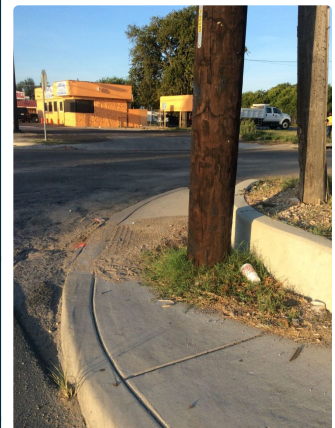
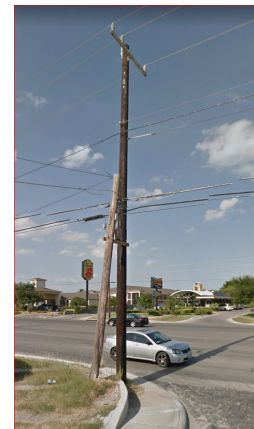
SITE PHOTOS

OWNER	Utility	CPS	Corridor	WW WHITE
	Contact	JAKE MARTINEZ	ID	114
GENERAL INFO	Utility	ELECTRIC		
	Size and Material	STANDARD POWER POLE, TIMBER		
	Utility Conflict Description	POLE WITHIN PROPOSED SIDEWALK		
	Longitudinal or Crossing	CROSSING		
	Placement Relative to ROW	INSIDE		
LOCATION	Sheet No.	220		
	Station Origin			
	Start Station	682+18.57	End Station	
	Start Offset	29.73	End Offset	
	Latitude	29.426389573	Longitude	-98.405727325000001
SUE	Level of Investigation Req'd	NONE		
	Test Hole No	N/A		
	Test Hole Depth	N/A		
RESOLUTION	Recommended Action	ACCOMMODATE - RELOCATION		
	Estimated Resolution Date			
	Resolution Status	UTILITY COORDINATION IN PROGRESS

Comment	INSUFFICIENT CLEARANCE PER PROWAG, 48" CLEARANCE REQUIRED. REMOVE ORIGINAL (BROKEN) TIMBER POLE, RELOCATE CONFLICTING POLE TO ORIGINAL LOCATION.		
Date Collected		8/11/2017 7:37:32 AM	Date Modified	
			11/30/2017 8:04:29 AM
