Utility Conflict Report

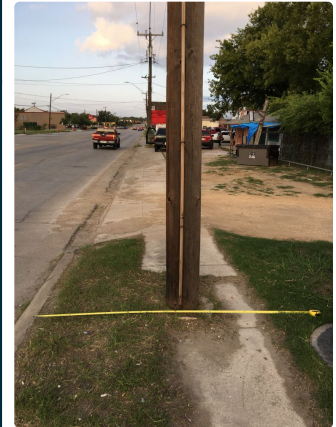
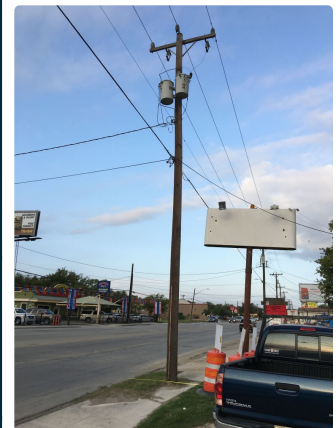
OWNER	Utility	CPS	Corridor	RIGSBY	SITE PHOTOS
	Contact	JAKE MARTINEZ	ID	227	
GENERAL INFO	Utility	ELECTRIC			
	Size and Material	STANDARD POWER POLE, TIMBER			
	Utility Conflict Description	POLE WITHIN PROPOSED SIDEWALK			
	Longitudinal or Crossing	CROSSING			
	Placement Relative to ROW	INSIDE			
LOCATION	Sheet No.	325			
	Station Origin				
	Start Station	654+35.27	End Station		
	Start Offset	9.30	End Offset		
	Latitude	29.398162494	Longitude	-98.433792564000001	
SUE	Level of Investigation Req'd	NONE			
	Test Hole No	N/A			
	Test Hole Depth	N/A			
RESOLUTION	Recommended Action	ACCOMODATE - RELOCATION			
	Estimated Resolution Date				
	Resolution Status	UTILITY COORDINATION IN PROGRESS

Comment	INSUFFICIENT CLEARANCE PER PROWAG, 48" CLEARANCE REQUIRED. 44" BACK OF CURB TO FACE OF POLE, 13" POLE DIA, 26" BACK OF POLE TO ROW (BACK OF SIDEWALK)			
Date Collected		9/20/2017 7:21:56 PM	Date Modified		11/27/2017 10:44:41 AM
