## Utility Conflict Report

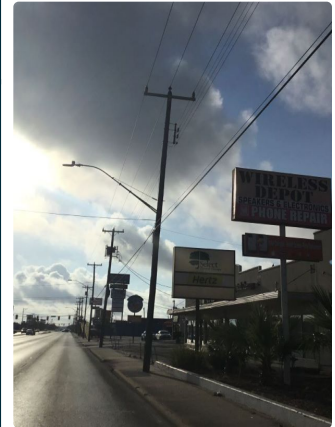
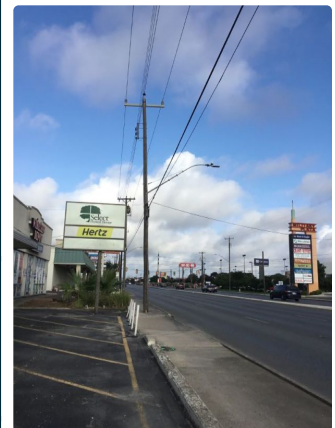
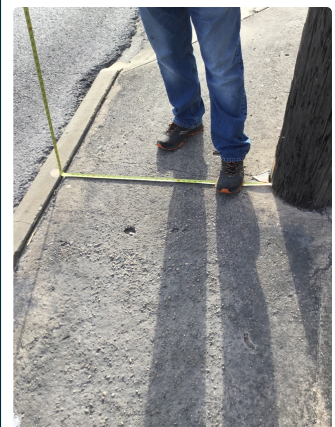
<b>OWNER</b>	<b>Utility</b>	CHARTER	<b>Corridor</b>	SW MILITARY	<b>SITE PHOTOS</b>
	<b>Contact</b>	FRANK CYPRIAN	<b>ID</b>	1094	
<b>GENERAL INFO</b>	<b>Utility</b>	COMMUNICATIONS			
	<b>Size and Material</b>	OVERHEAD TELECOMM LINES			
	<b>Accessible Route</b>	ASSET IS INSIDE ACCESSIBLE ROUTE			
	<b>Longitudinal or Crossing</b>	LONGITUDINAL			
	<b>Placement Relative to ROW</b>	INSIDE ROW			
<b>LOCATION</b>	<b>Sheet No.</b>	166			
	<b>Station</b>	720+96.71			
	<b>Offset</b>	15.62			
	<b>Latitude</b>	+29.356581			
	<b>Longitude</b>	-98.50049			
<b>SUE</b>	<b>Level of Investigation Req'd</b>	NONE			
	<b>Test Hole No</b>	N/A			
	<b>Test Hole Depth</b>	N/A			
<b>RESOLUTION</b>	<b>Recommended Action</b>	NO CONFLICT			
	<b>Estimated Resolution Date</b>				
	<b>Resolution Status</b>	NO RESOLUTION WAS REQUIRED			
	<b>Comment</b>	Related to utility ID 4213			
<b>Date Collected</b>		<b>Date Modified</b>		12/18/2018 4:05:08 PM
