## Utility Conflict Report

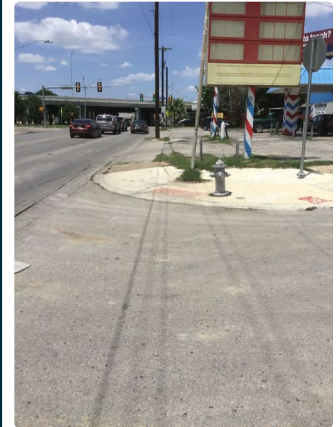
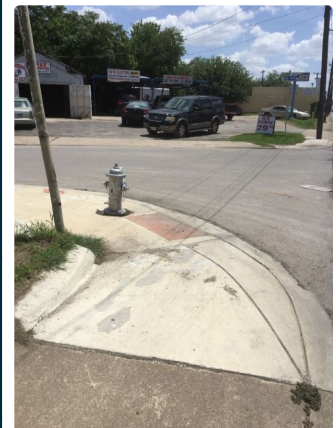
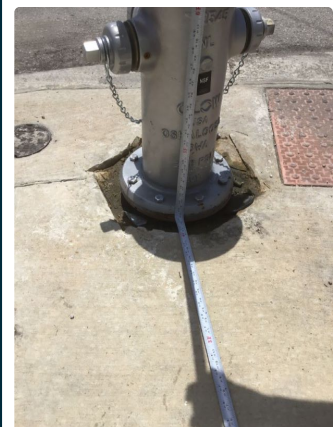
<b>OWNER</b>	<b>Utility</b>	SAWS	<b>Corridor</b>	NOGALITOS	<b>SITE PHOTOS</b>
	<b>Contact</b>	NINA BITTLE	<b>ID</b>	3076	
<b>GENERAL INFO</b>	<b>Utility</b>	WATER			
	<b>Size and Material</b>	STANDARD FIRE HYDRANT			
	<b>Accessible Route</b>	ASSET IS INSIDE ACCESSIBLE ROUTE			
	<b>Longitudinal or Crossing</b>	CROSSING			
	<b>Placement Relative to ROW</b>	INSIDE ROW			
<b>LOCATION</b>	<b>Sheet No.</b>				
	<b>Station</b>	141+57.96			
	<b>Offset</b>	29.9767			
	<b>Latitude</b>	+29.395149			
	<b>Longitude</b>	-98.51622			
<b>SUE</b>	<b>Level of Investigation Req'd</b>	NONE			
	<b>Test Hole No</b>	N/A			
	<b>Test Hole Depth</b>	N/A			
<b>RESOLUTION</b>	<b>Recommended Action</b>	NO CONFLICT			
	<b>Estimated Resolution Date</b>	8/13/2018			
	<b>Resolution Status</b>	NO RESOLUTION WAS REQUIRED			
	<b>Comment</b>	Hydrant to face of wall = 4'-2 1/2" Sidewalk width = 7'-0"			
<b>Date Collected</b>		7/11/2018 2:53:04 PM		<b>Date Modified</b> 8/14/2018 4:38:26 PM
