Utility Conflict Report

| OWNER | Utility | SAWS | Corridor | RIGSBY | SITE PHOTOS | |
| | Contact | ANN PECHE | ID | 312 | | |

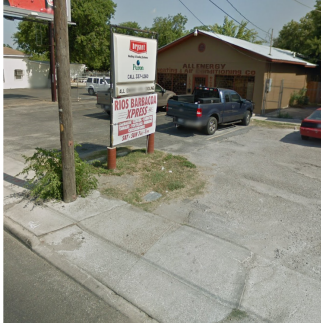
| | Size and Material | STANDARD WATER METER, CAST IRON | | | | |
| | Accessible Route | ASSET IS INSIDE ACCESSIBLE ROUTE | | | | |
| | Comment | Meter within driveway outside accessible route | | | | |

| RESOLUTION | Recommended Action | MINIMIZE - PROTECT IN PLACE | | | | |
