## Utility Conflict Report

<b>OWNER</b>	<b>Utility</b>	PRIVATE	<b>Corridor</b>	SW MILITARY	<b>SITE PHOTOS</b>	
	<b>Contact</b>	UNKNOWN	<b>ID</b>	3155		
<b>GENERAL INFO</b>	<b>Utility</b>	UNKNOWN

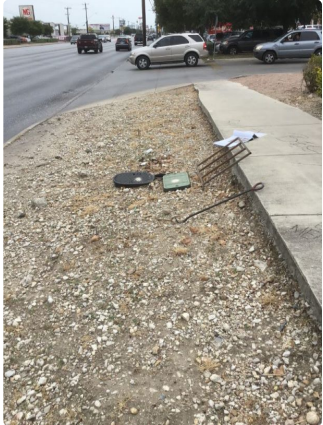
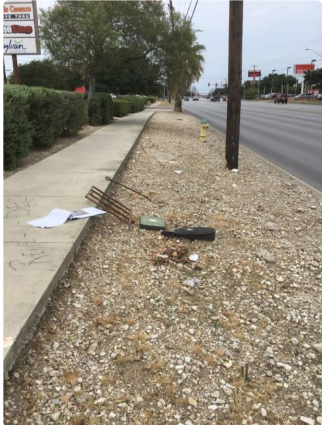
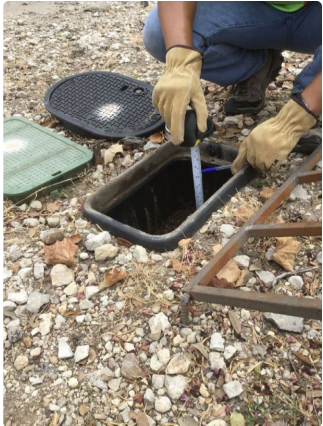
<b>Size and Material</b>	IRRIGATION VALVE				
	<b>Accessible Route</b>	ASSET IS OUTSIDE ACCESSIBLE ROUTE				
	<b>Longitudinal or Crossing</b>	CROSSING				
	<b>Placement Relative to ROW</b>	INSIDE ROW				
<b>LOCATION</b>	<b>Sheet No.</b>	144

<b>Test Hole No</b>	N/A				
	<b>Test Hole Depth</b>	N/A				
<b>RESOLUTION</b>	<b>Recommended Action</b>	NO CONFLICT				
	<b>Estimated Resolution Date</b>					
	<b>Resolution Status</b>	NO RESOLUTION WAS REQUIRED				
	<b>Comment</b>	Top of valve to surface = 6 1/2" Lid flange thickness = 1/4" Total lid thickness = 2" Valve to front of sidewalk = 1'-7" Vertical difference between top of lid and top of sidewalk = 10"-12"
