## Utility Conflict Report

<b>OWNER</b>	<b>Utility</b>	CPS	<b>Corridor</b>	SW MILITARY	<b>SITE PHOTOS</b>	
	<b>Contact</b>	JAKE MARTINEZ	<b>ID</b>	3169		
<b>GENERAL INFO</b>	<b>Utility</b>	ELECTRIC

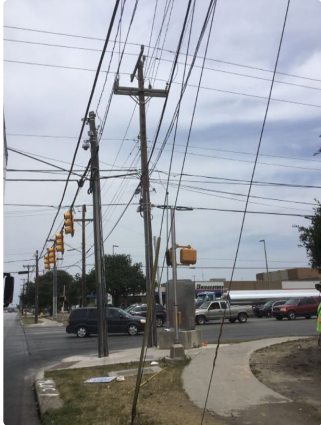
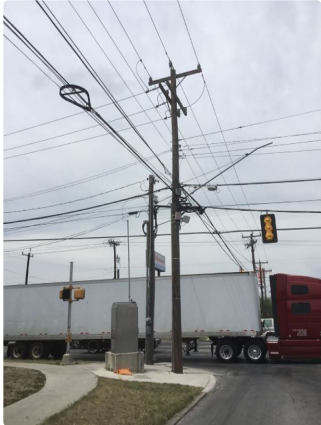
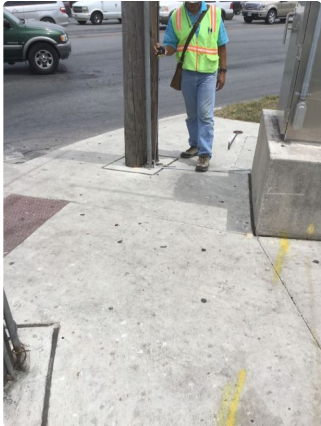
<b>Size and Material</b>	STANDARD POWER POLE, TIMBER				
	<b>Accessible Route</b>	ASSET IS INSIDE ACCESSIBLE ROUTE				
	<b>Longitudinal or Crossing</b>	CROSSING				
	<b>Placement Relative to ROW</b>	INSIDE ROW

<b>Test Hole No</b>	N/A				
	<b>Test Hole Depth</b>	N/A				
<b>RESOLUTION</b>	<b>Recommended Action</b>	NO CONFLICT				
	<b>Estimated Resolution Date</b>					
	<b>Resolution Status</b>	NO RESOLUTION WAS REQUIRED				
	<b>Comment</b>	Pole conduit to electrical box concrete pedestal = 3'-3" Back of curb to pole = 2'-8" No pole ID
