## Utility Conflict Report

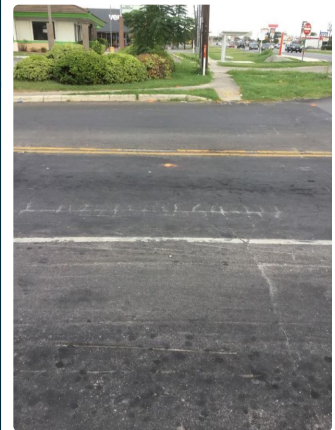
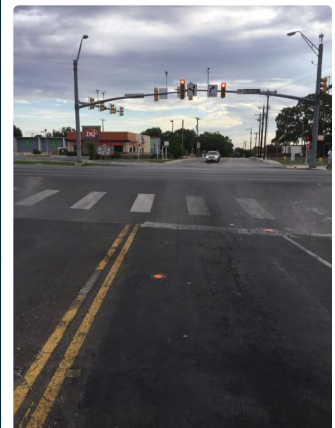
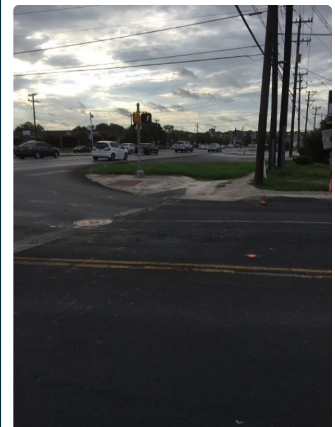
<b>OWNER</b>	<b>Utility</b>	SAWS	<b>Corridor</b>	BANDERA	<b>SITE PHOTOS</b>
	<b>Contact</b>	ANN PECHE	<b>ID</b>	3223	
<b>GENERAL INFO</b>	<b>Utility</b>	WATER			
	<b>Size and Material</b>	STANDARD WATER VALVE, CAST IRON			
	<b>Accessible Route</b>	ASSET IS OUTSIDE ACCESSIBLE ROUTE			
	<b>Longitudinal or Crossing</b>	CROSSING			
	<b>Placement Relative to ROW</b>	INSIDE ROW			
<b>LOCATION</b>	<b>Sheet No.</b>				
	<b>Station</b>				
	<b>Offset</b>				
	<b>Latitude</b>	+29.496167			
	<b>Longitude</b>	-98.62021			
<b>SUE</b>	<b>Level of Investigation Req'd</b>	NONE			
	<b>Test Hole No</b>	N/A			
	<b>Test Hole Depth</b>	N/A			
<b>RESOLUTION</b>	<b>Recommended Action</b>	NO CONFLICT			
	<b>Estimated Resolution Date</b>	9/13/2018			
	<b>Resolution Status</b>	NO RESOLUTION WAS REQUIRED			
	<b>Comment</b>	Unable to open lid			
<b>Date Collected</b>		8/20/2018 8:20:41 AM		<b>Date Modified</b> 11/28/2018 6:59:12 AM
