Utility Conflict Report

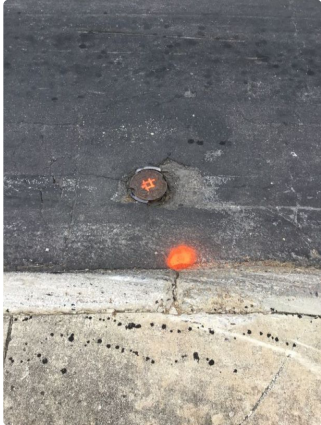
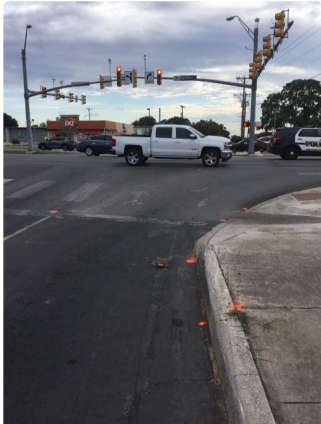
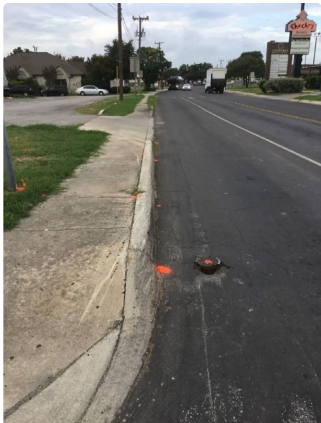
OWNER	Utility	SAWS	Corridor	BANDERA	SITE PHOTOS
	Contact	ANN PECHE	ID	3224	
GENERAL INFO	Utility	WATER			
	Size and Material	STANDARD WATER VALVE, CAST IRON			
	Accessible Route	ASSET IS OUTSIDE ACCESSIBLE ROUTE			
	Longitudinal or Crossing	CROSSING			
	Placement Relative to ROW	INSIDE ROW			
LOCATION	Sheet No.				
	Station				
	Offset				
	Latitude	+29.496171			
	Longitude	-98.62017			
SUE	Level of Investigation Req'd	NONE			
	Test Hole No	N/A			
	Test Hole Depth	N/A			
RESOLUTION	Recommended Action	NO CONFLICT			
	Estimated Resolution Date	9/13/2018			
	Resolution Status	NO RESOLUTION WAS REQUIRED			
	Comment	Front of curb to valve = 1'-1 1/2" Unable to open lid Valve lid is damaged			
Date Collected		8/20/2018 8:23:09 AM		Date Modified 11/28/2018 6:59:12 AM
