## Utility Conflict Report

<b>OWNER</b>	<b>Utility</b>	SAWS	<b>Corridor</b>	BANDERA	<b>SITE PHOTOS</b>	
	<b>Contact</b>	ANN PECHE	<b>ID</b>	3230		
<b>GENERAL INFO</b>	<b>Utility</b>	WATER

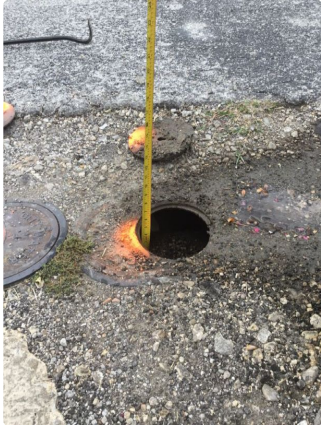
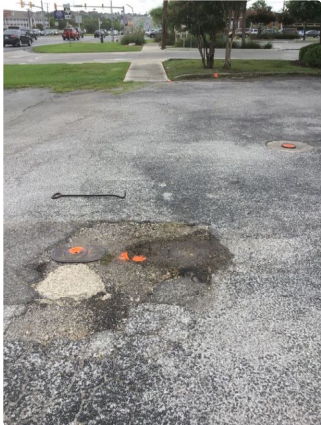
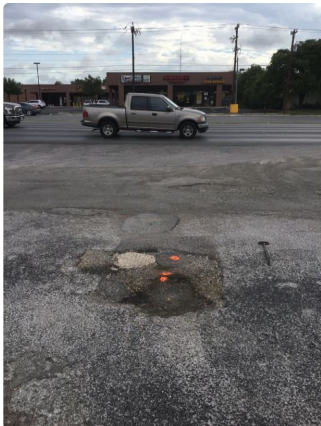
<b>Size and Material</b>	STANDARD WATER VALVE, CAST IRON				
	<b>Accessible Route</b>	ASSET IS OUTSIDE ACCESSIBLE ROUTE				
	<b>Longitudinal or Crossing</b>	CROSSING				
	<b>Placement Relative to ROW</b>	INSIDE ROW				
<b>LOCATION</b>	<b>Sheet No.</b>	307

<b>Station</b>	1779+50				
	<b>Offset</b>	-40				
	<b>Latitude</b>	+29.495467				
	<b>Longitude</b>	-98.61928				
<b>SUE</b>	<b>Level of Investigation Req'd</b>	NONE

<b>Estimated Resolution Date</b>	12/3/2018				
	<b>Resolution Status</b>	NO RESOLUTION WAS REQUIRED				
	<b>Comment</b>	Top of valve to surface = 3 3/4"				
<b>Date Collected</b>		8/20/2018 8:49:39 AM		<b>Date Modified</b> 12/3/2018 8:10:30 AM

<b>Test Hole No</b>	N/A				
	<b>Test Hole Depth</b>	N/A				
<b>RESOLUTION</b>	<b>Recommended Action</b>	NO CONFLICT
