Utility Conflict Report

| OWNER | Utility | SAWS | Corridor | BANDERA | SITE PHOTOS |
| | Contact | ANN PECHE | ID | 3241 | |

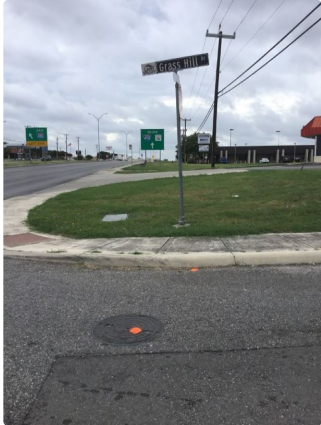
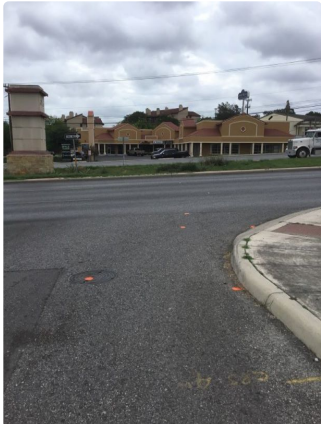
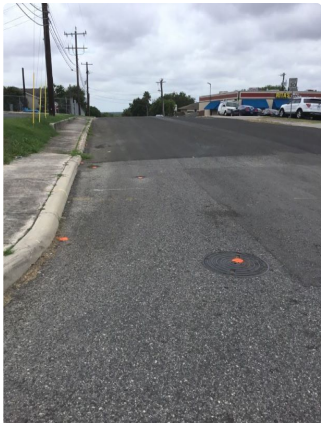
| RESOLUTION | Recommended Action | NO CONFLICT | | | |
| | Comment | Face of curb to manhole = 5'-9" Unable to open manhole | | | |
