## Utility Conflict Report

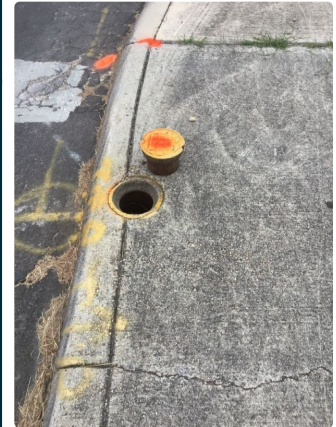
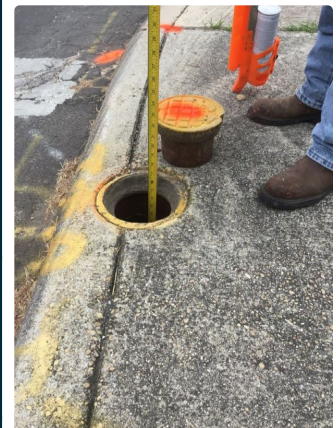
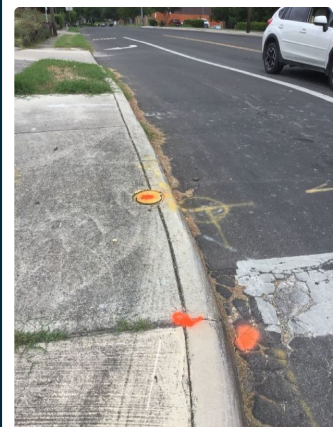
<b>OWNER</b>	<b>Utility</b>	CPS	<b>Corridor</b>	BANDERA	<b>SITE PHOTOS</b>		
	<b>Contact</b>	BILL FEY	<b>ID</b>	3249			
<b>GENERAL INFO</b>	<b>Utility</b>	GAS					
	<b>Size and Material</b>	STANDARD GAS VALVE, CAST IRON					
	<b>Accessible Route</b>	ASSET IS INSIDE ACCESSIBLE ROUTE					
	<b>Longitudinal or Crossing</b>	CROSSING					
	<b>Placement Relative to ROW</b>	INSIDE ROW					
<b>LOCATION</b>	<b>Sheet No.</b>	234					
	<b>Station</b>	1753+65.74					
	<b>Offset</b>	-38.16					
	<b>Latitude</b>	+29.490944					
	<b>Longitude</b>	-98.61305					
<b>SUE</b>	<b>Level of Investigation Req'd</b>	NONE					
	<b>Test Hole No</b>	N/A					
	<b>Test Hole Depth</b>	N/A					
<b>RESOLUTION</b>	<b>Recommended Action</b>	MINIMIZE - PROTECT IN PLACE					
	<b>Estimated Resolution Date</b>						
	<b>Resolution Status</b>	UTILITY OWNER INFORMED OF UTILITY					
	<b>Comment</b>	Valve adjacent to back of curb Top of valve to surface = 15 1/4" Lid thickness = 1 1/2"
