Utility Conflict Report

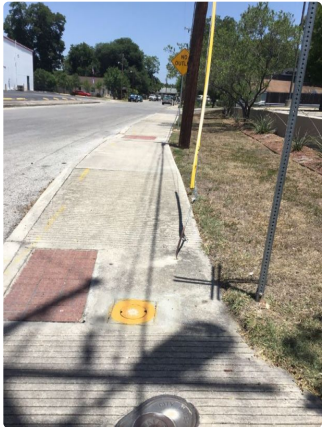
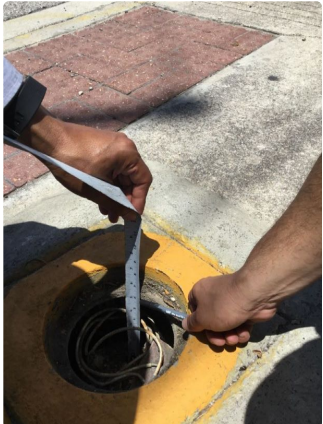
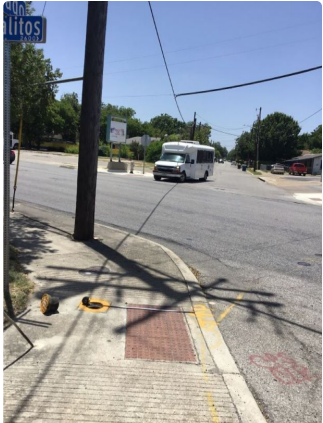
OWNER	Utility	CPS	Corridor	NOGALITOS	SITE PHOTOS		
	Contact	BILL FEY	ID	4026			
GENERAL INFO	Utility	GAS					
	Size and Material	STANDARD GAS VALVE, CAST IRON					
	Accessible Route	ASSET IS INSIDE ACCESSIBLE ROUTE					
	Longitudinal or Crossing	CROSSING					
	Placement Relative to ROW	INSIDE ROW					
LOCATION	Sheet No.	113					
	Station	111+90.02					
	Offset	29.7					
	Latitude	+29.388631					
	Longitude	-98.52190					
SUE	Level of Investigation Req'd	NONE					
	Test Hole No	N/A					
	Test Hole Depth	N/A					
RESOLUTION	Recommended Action	MINIMIZE - PROTECT IN PLACE					
	Estimated Resolution Date						
	Resolution Status	UTILITY OWNER INFORMED OF UTILITY					
	Comment	Back of curb to valve = 3'-3" Top of valve to surface = 6.5" Lid thickness = 1.5"					
Date Collected		7/2/2018 2:13:12 PM		Date Modified		10/12/2018 3:14:06 PM
