Utility Conflict Report

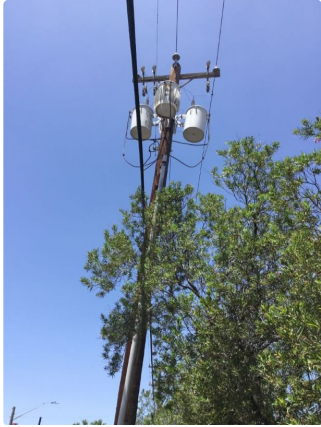
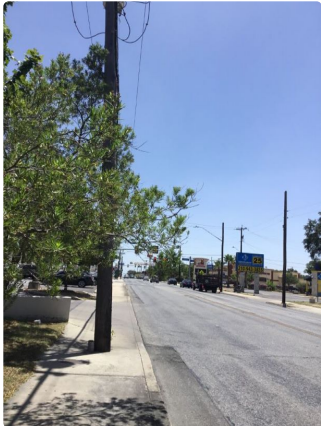
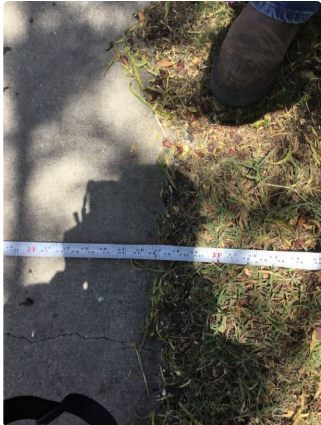
OWNER	Utility	CPS	Corridor	NOGALITOS	SITE PHOTOS		
	Contact	JAKE MARTINEZ	ID	4027			
GENERAL INFO	Utility	ELECTRIC					
	Size and Material	STANDARD POWER POLE, TIMBER					
	Accessible Route	ASSET IS INSIDE ACCESSIBLE ROUTE					
	Longitudinal or Crossing	CROSSING					
	Placement Relative to ROW	INSIDE ROW					
LOCATION	Sheet No.						
	Station	110+66.83					
	Offset	23.8067					
	Latitude	+29.388413					
	Longitude	-98.52215					
SUE	Level of Investigation Req'd	NONE					
	Test Hole No	N/A					
	Test Hole Depth	N/A					
RESOLUTION	Recommended Action	NO CONFLICT					
	Estimated Resolution Date	8/13/2018					
	Resolution Status	NO RESOLUTION WAS REQUIRED					
	Comment	Pole to back of curb = 2'-1" Pipe (adjacent to pole) to back of sidewalk = 2'-9" CATV cable					
Date Collected		7/2/2018 2:19:57 PM		Date Modified		8/14/2018 4:38:26 PM
