## Utility Conflict Report

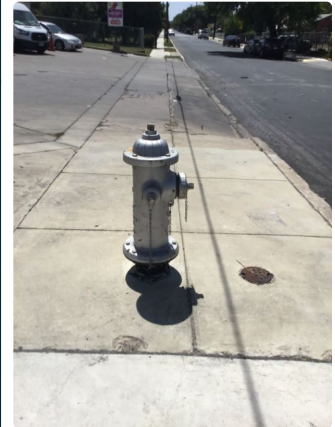
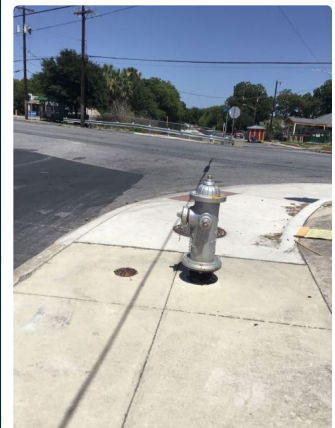
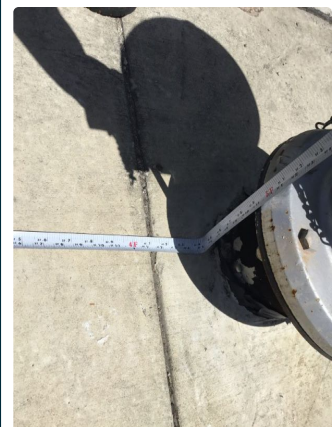
<b>OWNER</b>	<b>Utility</b>	SAWS	<b>Corridor</b>	NOGALITOS	<b>SITE PHOTOS</b>		
	<b>Contact</b>	NINA BITTLE	<b>ID</b>	4033			
<b>GENERAL INFO</b>	<b>Utility</b>	WATER					
	<b>Size and Material</b>	STANDARD FIRE HYDRANT					
	<b>Accessible Route</b>	ASSET IS INSIDE ACCESSIBLE ROUTE					
	<b>Longitudinal or Crossing</b>	CROSSING					
	<b>Placement Relative to ROW</b>	INSIDE ROW					
<b>LOCATION</b>	<b>Sheet No.</b>						
	<b>Station</b>	114+72.13					
	<b>Offset</b>	-45.7665					
	<b>Latitude</b>	+29.389428					
	<b>Longitude</b>	-98.52146					
<b>SUE</b>	<b>Level of Investigation Req'd</b>	NONE					
	<b>Test Hole No</b>	N/A					
	<b>Test Hole Depth</b>	N/A					
<b>RESOLUTION</b>	<b>Recommended Action</b>	NO CONFLICT					
	<b>Estimated Resolution Date</b>	8/13/2018					
	<b>Resolution Status</b>	NO RESOLUTION WAS REQUIRED					
	<b>Comment</b>	Fire hydrant to back of curb = 4'-2" Sidewalk width = 8'-2"					
<b>Date Collected</b>		7/2/2018 3:25:19 PM		<b>Date Modified</b>		8/14/2018 4:38:26 PM
