## Utility Conflict Report

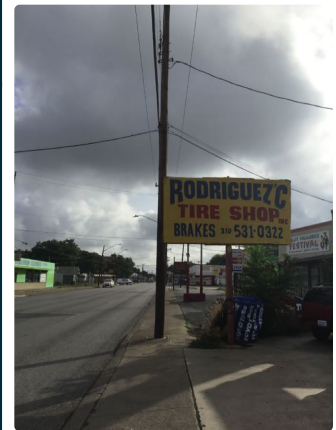
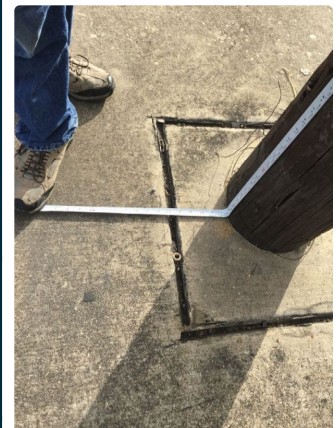
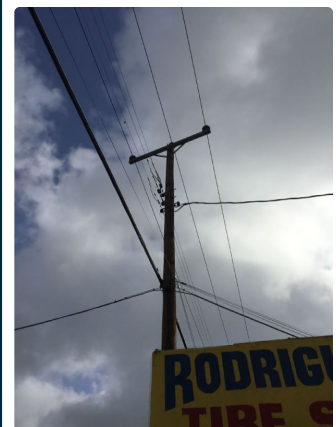
<b>OWNER</b>	<b>Utility</b>	CPS	<b>Corridor</b>	NOGALITOS	<b>SITE PHOTOS</b>		
	<b>Contact</b>	JAKE MARTINEZ	<b>ID</b>	4054			
<b>GENERAL INFO</b>	<b>Utility</b>	ELECTRIC					
	<b>Size and Material</b>	STANDARD POWER POLE, TIMBER					
	<b>Accessible Route</b>	ASSET IS INSIDE ACCESSIBLE ROUTE					
	<b>Longitudinal or Crossing</b>	CROSSING					
	<b>Placement Relative to ROW</b>	INSIDE ROW					
<b>LOCATION</b>	<b>Sheet No.</b>	78					
	<b>Station</b>	121+55.05					
	<b>Offset</b>	23.61					
	<b>Latitude</b>	+29.390800					
	<b>Longitude</b>	-98.52001					
<b>SUE</b>	<b>Level of Investigation Req'd</b>	NONE					
	<b>Test Hole No</b>	N/A					
	<b>Test Hole Depth</b>	N/A					
<b>RESOLUTION</b>	<b>Recommended Action</b>	MINIMIZE - PROTECT IN PLACE					
	<b>Estimated Resolution Date</b>						
	<b>Resolution Status</b>	UTILITY OWNER INFORMED OF UTILITY					
	<b>Comment</b>	Pole to back of curb = 2'-3" pole to back of sidewalk = 3'-8" Sidewalk width = 7'-0" CATV cable
