## Utility Conflict Report

<b>OWNER</b>	<b>Utility</b>	CPS	<b>Corridor</b>	NOGALITOS	<b>SITE PHOTOS</b>	
	<b>Contact</b>	JAKE MARTINEZ	<b>ID</b>	4080		
<b>GENERAL INFO</b>	<b>Utility</b>	ELECTRIC

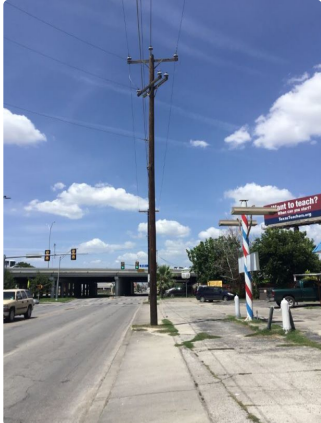
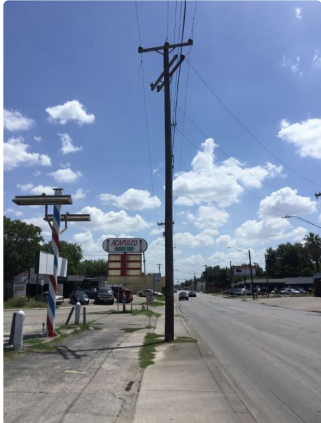
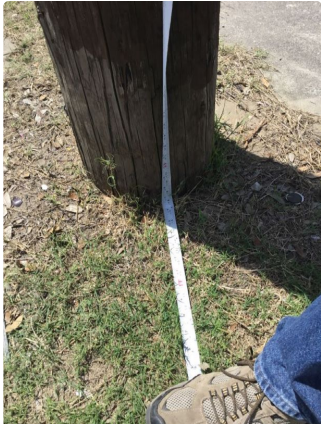
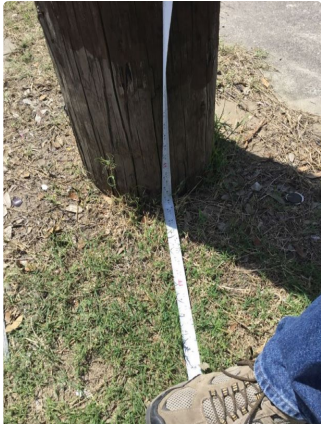
<b>Size and Material</b>	STANDARD POWER POLE, TIMBER				
	<b>Accessible Route</b>	ASSET IS INSIDE ACCESSIBLE ROUTE				
	<b>Longitudinal or Crossing</b>	CROSSING				
	<b>Placement Relative to ROW</b>	INSIDE ROW				
<b>LOCATION</b>	<b>Sheet No.</b>	89

<b>Estimated Resolution Date</b>					
	<b>Resolution Status</b>	UTILITY OWNER INFORMED OF UTILITY				
	<b>Comment</b>	Pole to back of sidewalk = 1'-8" Pole to back of curb = 2'-6" Sidewalk width = 5'-0" No pole ID

<b>Test Hole No</b>	N/A				
	<b>Test Hole Depth</b>	N/A				
<b>RESOLUTION</b>	<b>Recommended Action</b>	MINIMIZE - PROTECT IN PLACE
