## Utility Conflict Report

<b>OWNER</b>	<b>Utility</b>	CPS	<b>Corridor</b>	SW MILITARY	<b>SITE PHOTOS</b>		
	<b>Contact</b>	JAKE MARTINEZ	<b>ID</b>	4091			
<b>GENERAL INFO</b>	<b>Utility</b>	ELECTRIC

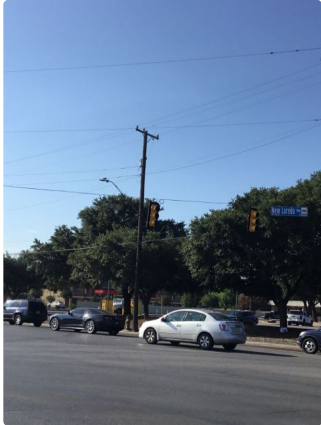
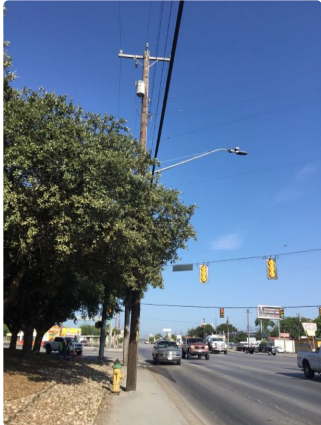
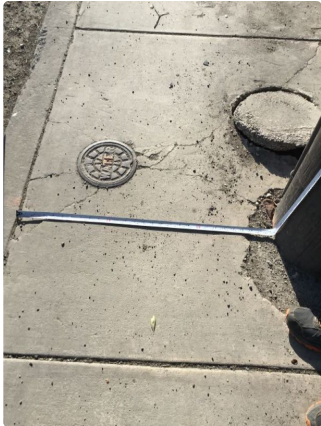
<b>Size and Material</b>	STANDARD POWER POLE, TIMBER					
	<b>Accessible Route</b>	ASSET IS INSIDE ACCESSIBLE ROUTE					
	<b>Longitudinal or Crossing</b>	CROSSING					
	<b>Placement Relative to ROW</b>	INSIDE ROW					
<b>LOCATION</b>	<b>Sheet No.</b>

<b>Test Hole No</b>	N/A					
	<b>Test Hole Depth</b>	N/A					
<b>RESOLUTION</b>	<b>Recommended Action</b>	NO CONFLICT					
	<b>Estimated Resolution Date</b>	11/21/2018					
	<b>Resolution Status</b>	NO RESOLUTION WAS REQUIRED					
	<b>Comment</b>	Pole ID: LW 34872; 506163 Pole to back of sidewalk = 2'-1" Back of curb to pole = 2'-10" Pole diameter = 14" Sidewalk width = 6'-0"
