## Utility Conflict Report

<b>OWNER</b>	<b>Utility</b>	CPS	<b>Corridor</b>	SW MILITARY	<b>SITE PHOTOS</b>		
	<b>Contact</b>	JAKE MARTINEZ	<b>ID</b>	4095			
<b>GENERAL INFO</b>	<b>Utility</b>	ELECTRIC

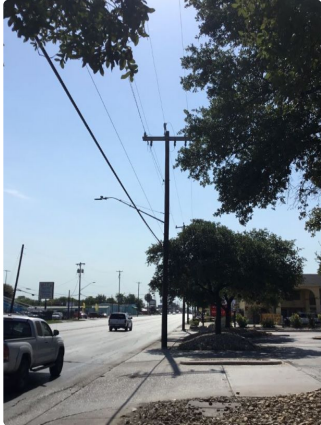
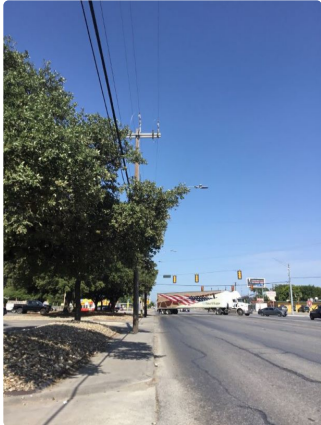
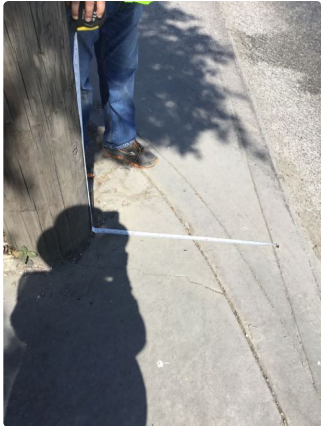
<b>Size and Material</b>	STANDARD POWER POLE, TIMBER					
	<b>Accessible Route</b>	ASSET IS INSIDE ACCESSIBLE ROUTE					
	<b>Longitudinal or Crossing</b>	CROSSING					
	<b>Placement Relative to ROW</b>	INSIDE ROW					
<b>LOCATION</b>	<b>Sheet No.</b>

<b>Test Hole No</b>	N/A					
	<b>Test Hole Depth</b>	N/A					
<b>RESOLUTION</b>	<b>Recommended Action</b>	NO CONFLICT					
	<b>Estimated Resolution Date</b>	11/21/2018					
	<b>Resolution Status</b>	NO RESOLUTION WAS REQUIRED					
	<b>Comment</b>	Pole ID: LW 47011; 482418 Back of curb to pole = 2'-6" Pole to back of sidewalk = 2'-8" Sidewalk width = 6'-3"
