## Utility Conflict Report

<b>OWNER</b>	<b>Utility</b>	SAWS	<b>Corridor</b>	SW MILITARY	<b>SITE PHOTOS</b>

<b>Contact</b>	ANN PECHE	<b>ID</b>	4098			
<b>GENERAL INFO</b>	<b>Utility</b>	WATER

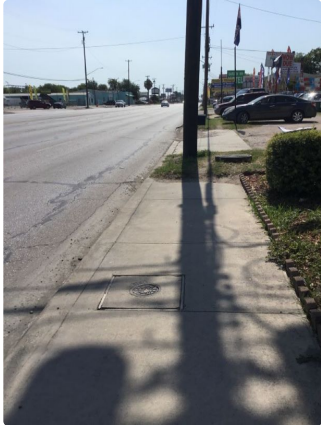
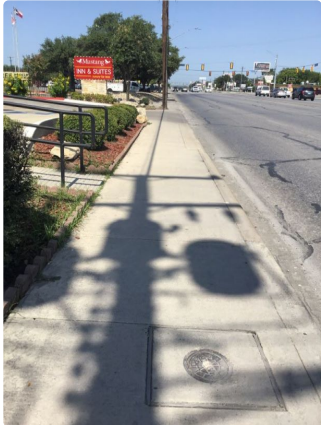
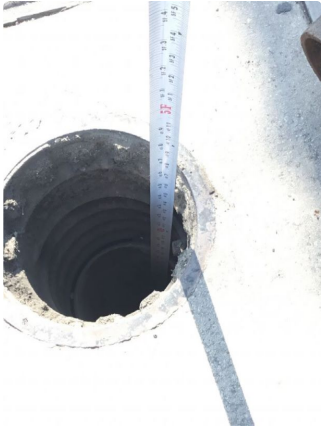
<b>Size and Material</b>	STANDARD WATER VALVE, CAST IRON					
	<b>Accessible Route</b>	ASSET IS INSIDE ACCESSIBLE ROUTE					
	<b>Longitudinal or Crossing</b>	CROSSING					
	<b>Placement Relative to ROW</b>	INSIDE ROW					
<b>LOCATION</b>	<b>Sheet No.</b>

<b>Station</b>	536+71.49					
	<b>Offset</b>	13.9951					
	<b>Latitude</b>	+29.358044					
	<b>Longitude</b>	-98.55820					
<b>SUE</b>	<b>Level of Investigation Req'd</b>	NONE					
	<b>Test Hole No</b>	N/A					
	<b>Test Hole Depth</b>	N/A					
<b>RESOLUTION</b>	<b>Recommended Action</b>	NO CONFLICT					
	<b>Estimated Resolution Date</b>						
	<b>Resolution Status</b>	NO RESOLUTION WAS REQUIRED					
	<b>Comment</b>	Back of sidewalk to valve = 3'-1" Back of curb to valve = 1'-1.5" Sidewalk width = 5'-0" Bottom of valve to surface = 4'-6" Lid thickness = 2"
