## Utility Conflict Report

| <b>OWNER</b> | <b>Utility</b> | SAWS | <b>Corridor</b> | SW MILITARY | <b>SITE PHOTOS</b> | | |
| | <b>Contact</b> | ANN PECHE | <b>ID</b> | 4112 | | | |

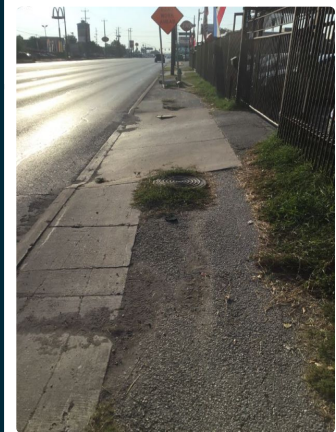
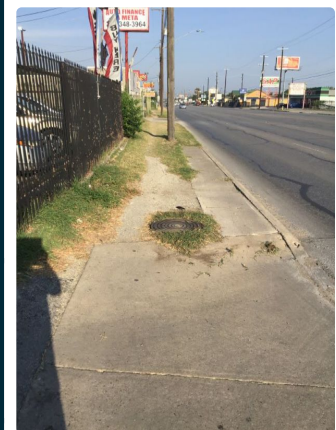
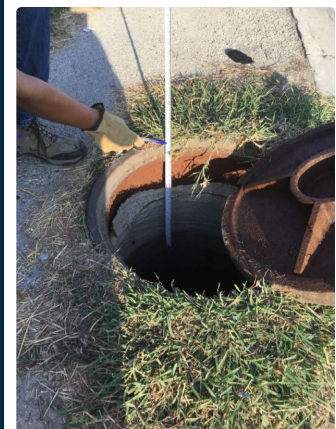
| <b>GENERAL INFO</b> | <b>Utility</b> | SANITARY SEWER | | | | | |
| | <b>Size and Material</b> | STANDARD MANHOLE, CAST IRON | | | | | |
| | <b>Accessible Route</b> | ASSET IS INSIDE ACCESSIBLE ROUTE | | | | | |
| | <b>Comment</b> | Manhole to steel fence = 4'-0"<br>Manhole to back of sidewalk = 3"<br>Bottom of cone to surface = 1'-6"<br>Lid thickness = 1 1/2"<br>Sidewalk width = 3'-0" | | | | | |

| <b>RESOLUTION</b> | <b>Recommended Action</b> | MINIMIZE - PROTECT IN PLACE | | | | | |
