## Utility Conflict Report

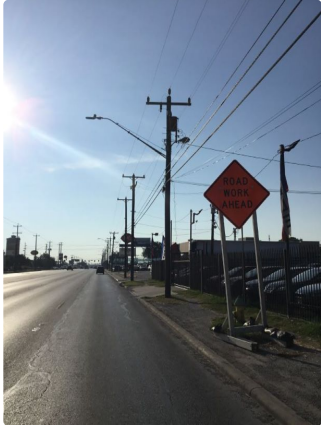
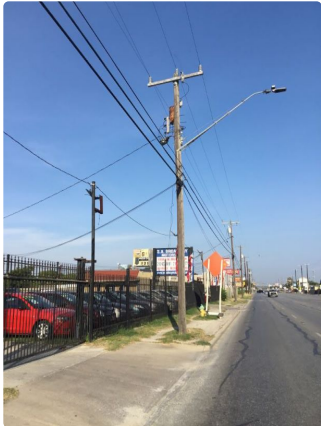
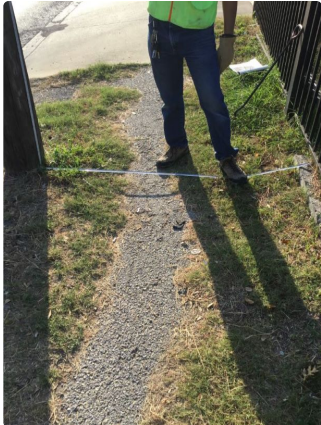
<b>OWNER</b>	<b>Utility</b>	CPS	<b>Corridor</b>	SW MILITARY	<b>SITE PHOTOS</b>
	<b>Contact</b>	JAKE MARTINEZ	<b>ID</b>	4114	
<b>GENERAL INFO</b>	<b>Utility</b>	ELECTRIC			
	<b>Size and Material</b>	STANDARD POWER POLE, TIMBER			
	<b>Accessible Route</b>	ASSET IS INSIDE ACCESSIBLE ROUTE			
	<b>Longitudinal or Crossing</b>	CROSSING			
	<b>Placement Relative to ROW</b>	INSIDE ROW			
<b>LOCATION</b>	<b>Sheet No.</b>	136			
	<b>Station</b>	557+30.23			
	<b>Offset</b>	15.6744			
	<b>Latitude</b>	+29.357427			
	<b>Longitude</b>	-98.55184			
<b>SUE</b>	<b>Level of Investigation Req'd</b>	NONE			
	<b>Test Hole No</b>	N/A			
	<b>Test Hole Depth</b>	N/A			
<b>RESOLUTION</b>	<b>Recommended Action</b>	NO CONFLICT			
	<b>Estimated Resolution Date</b>				
	<b>Resolution Status</b>	NO RESOLUTION WAS REQUIRED			
	<b>Comment</b>	Pole ID = LW52030; 434796 Pole to back of curb = 3'-0" Pole to steel fence = 6'-0" Back of curb to fence = 10'-0" CATV cable
