## Utility Conflict Report

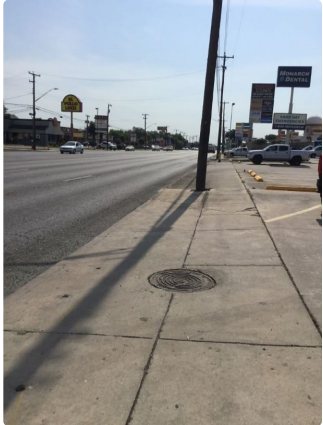
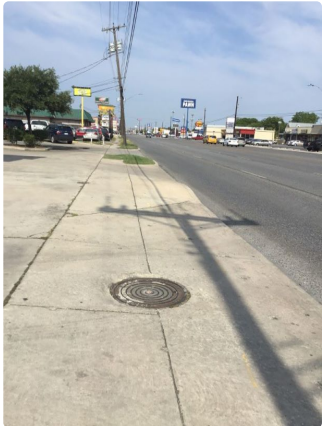
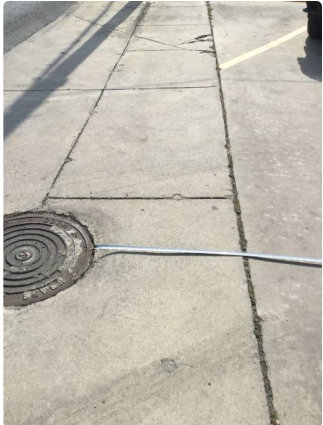
<b>OWNER</b>	<b>Utility</b>	SAWS	<b>Corridor</b>	SW MILITARY	<b>SITE PHOTOS</b>		
	<b>Contact</b>	ANN PECHE	<b>ID</b>	4167			
<b>GENERAL INFO</b>	<b>Utility</b>	SANITARY SEWER					
	<b>Size and Material</b>	STANDARD MANHOLE, CAST IRON					
	<b>Accessible Route</b>	ASSET IS INSIDE ACCESSIBLE ROUTE					
	<b>Longitudinal or Crossing</b>	CROSSING					
	<b>Placement Relative to ROW</b>	INSIDE ROW					
<b>LOCATION</b>	<b>Sheet No.</b>	158					
	<b>Station</b>	686+35.67					
	<b>Offset</b>	18.34					
	<b>Latitude</b>	+29.356553					
	<b>Longitude</b>	-98.51132					
<b>SUE</b>	<b>Level of Investigation Req'd</b>	NONE					
	<b>Test Hole No</b>	N/A					
	<b>Test Hole Depth</b>	N/A					
<b>RESOLUTION</b>	<b>Recommended Action</b>	MINIMIZE - PROTECT IN PLACE					
	<b>Estimated Resolution Date</b>						
	<b>Resolution Status</b>	UTILITY OWNER INFORMED OF UTILITY					
	<b>Comment</b>	Back of curb to manhole = 3'-10" Manhole lid = 2"-3" below roadway grade Back of sidewalk to manhole = 2'-6" Sidewalk width = 3'-10" Unable to open manhole
