## Utility Conflict Report

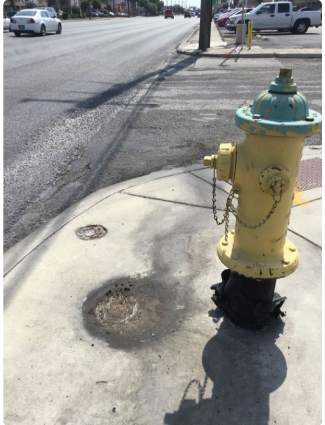
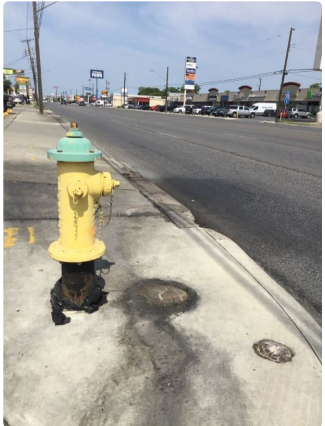
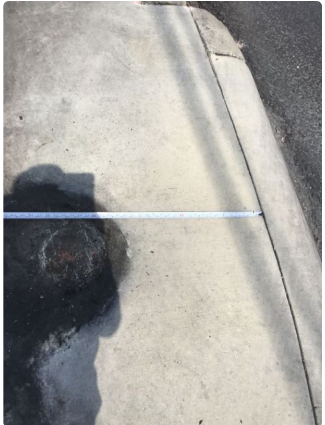
<b>OWNER</b>	<b>Utility</b>	SAWS	<b>Corridor</b>	SW MILITARY	<b>SITE PHOTOS</b>
	<b>Contact</b>	ANN PECHE	<b>ID</b>	4171	
<b>GENERAL INFO</b>	<b>Utility</b>	WATER			
	<b>Size and Material</b>	STANDARD WATER VALVE, CAST IRON			
	<b>Accessible Route</b>	ASSET IS INSIDE ACCESSIBLE ROUTE			
	<b>Longitudinal or Crossing</b>	CROSSING			
	<b>Placement Relative to ROW</b>	INSIDE ROW			
<b>LOCATION</b>	<b>Sheet No.</b>	158			
	<b>Station</b>	687+61.48			
	<b>Offset</b>	15.823			
	<b>Latitude</b>	+29.356606			
	<b>Longitude</b>	-98.51090			
<b>SUE</b>	<b>Level of Investigation Req'd</b>	NONE			
	<b>Test Hole No</b>	N/A			
	<b>Test Hole Depth</b>	N/A			
<b>RESOLUTION</b>	<b>Recommended Action</b>	NO CONFLICT			
	<b>Estimated Resolution Date</b>				
	<b>Resolution Status</b>	NO RESOLUTION WAS REQUIRED			
	<b>Comment</b>	Back of curb to valve = 1'-10" Face of wall to valve = 5'-3" Sidewalk width = 7'-10" Unable to open lid
