## Utility Conflict Report

<b>OWNER</b>	<b>Utility</b>	CPS	<b>Corridor</b>	SW MILITARY	<b>SITE PHOTOS</b>	
	<b>Contact</b>	JAKE MARTINEZ	<b>ID</b>	4192		
<b>GENERAL INFO</b>	<b>Utility</b>	ELECTRIC

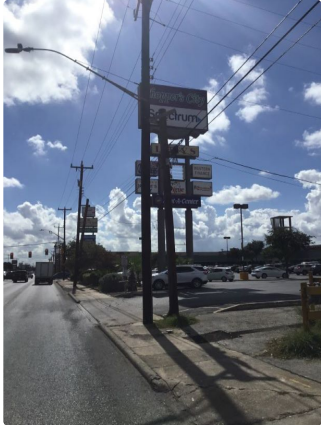
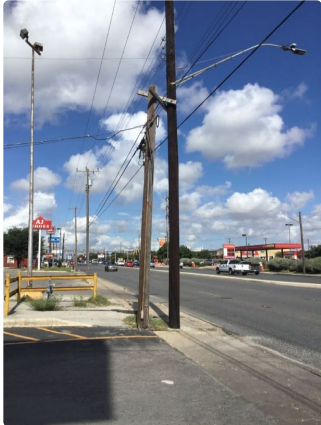
<b>Size and Material</b>	STANDARD POWER POLE, TIMBER				
	<b>Accessible Route</b>	ASSET IS INSIDE ACCESSIBLE ROUTE				
	<b>Longitudinal or Crossing</b>	CROSSING				
	<b>Placement Relative to ROW</b>	INSIDE ROW

<b>LOCATION</b>	<b>Sheet No.</b>	162				
	<b>Station</b>	714+98.43				
	<b>Offset</b>	19.335				
	<b>Latitude</b>	+29.356543				
	<b>Longitude</b>	-98.50249				
<b>SUE</b>	<b>Level of Investigation Req'd</b>	NONE			 	
	<b>Test Hole No</b>	N/A				
	<b>Test Hole Depth</b>	N/A				
<b>RESOLUTION</b>	<b>Recommended Action</b>	NO CONFLICT				
	<b>Estimated Resolution Date</b>					
	<b>Resolution Status</b>	NO RESOLUTION WAS REQUIRED				
	<b>Comment</b>	Pole ID: 383693; LW 60918 Pole within sidewalk Sidewalk width = 6'-11" Pole base in poor condition Pole attached to adjacent pole
