## Utility Conflict Report

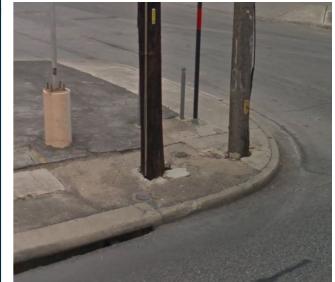
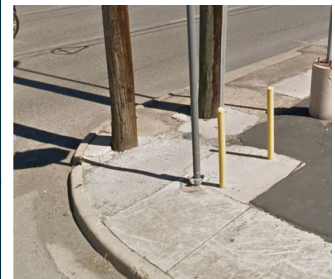
<b>OWNER</b>	<b>Utility</b>	SAWS	<b>Corridor</b>	SW MILITARY	<b>SITE PHOTOS</b>
	<b>Contact</b>	ANN PECHE	<b>ID</b>	4599	
<b>GENERAL INFO</b>	<b>Utility</b>	WATER			
	<b>Size and Material</b>	STANDARD WATER VALVE, CAST IRON			
	<b>Accessible Route</b>	ASSET IS INSIDE ACCESSIBLE ROUTE			
	<b>Longitudinal or Crossing</b>	CROSSING			
	<b>Placement Relative to ROW</b>	INSIDE ROW			
<b>LOCATION</b>	<b>Sheet No.</b>	158			
	<b>Station</b>	688+10.79			
	<b>Offset</b>	17.55			
	<b>Latitude</b>	+29.356551			
	<b>Longitude</b>	-98.510788			
<b>SUE</b>	<b>Level of Investigation Req'd</b>	NONE			
	<b>Test Hole No</b>	N/A			
	<b>Test Hole Depth</b>	N/A			
<b>RESOLUTION</b>	<b>Recommended Action</b>	MINIMIZE - PROTECT IN PLACE			
	<b>Estimated Resolution Date</b>				
	<b>Resolution Status</b>	UTILITY OWNER INFORMED OF UTILITY			
	<b>Comment</b>				
<b>Date Collected</b>		12/17/2018 2:42:04 PM	<b>Date Modified</b>		12/17/2018 3:01:20 PM
