## Utility Conflict Report

<b>OWNER</b>	<b>Utility</b>	CPS	<b>Corridor</b>	MILITARY	<b>SITE PHOTOS</b>

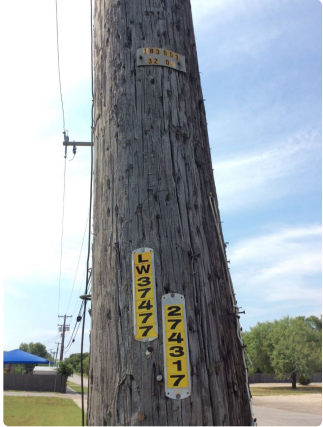
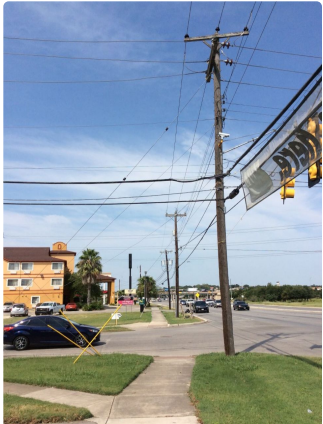
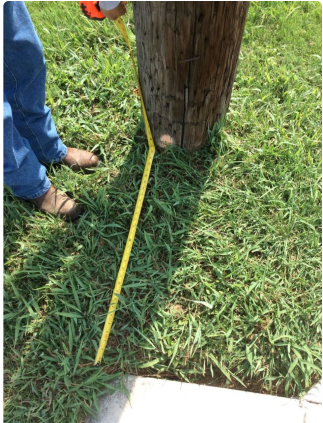
<b>Contact</b>	JAKE MARTINEZ	<b>ID</b>	7012	
<b>GENERAL INFO</b>	<b>Utility</b>	ELECTRIC			
	<b>Size and Material</b>	STANDARD POWER POLE, TIMBER			
	<b>Accessible Route</b>	ASSET IS OUTSIDE ACCESSIBLE ROUTE			
	<b>Longitudinal or Crossing</b>	CROSSING			
	<b>Placement Relative to ROW</b>	INSIDE ROW			
<b>LOCATION</b>	<b>Sheet No.</b>	227			
	<b>Station</b>	1092+05.51			
	<b>Offset</b>	31.6202			
	<b>Latitude</b>	+29.353450			
	<b>Longitude</b>	-98.42472			
<b>SUE</b>	<b>Level of Investigation Req'd</b>	NONE			
	<b>Test Hole No</b>	N/A			
	<b>Test Hole Depth</b>	N/A			
<b>RESOLUTION</b>	<b>Recommended Action</b>	NO CONFLICT			
	<b>Estimated Resolution Date</b>	8/13/2018			
	<b>Resolution Status</b>	NO RESOLUTION WAS REQUIRED			
	<b>Comment</b>	Pole to front of sidewalk = 3'-2" Back of curb to pole = 2'-6" Sufficient vertical clearance
