## Utility Conflict Report

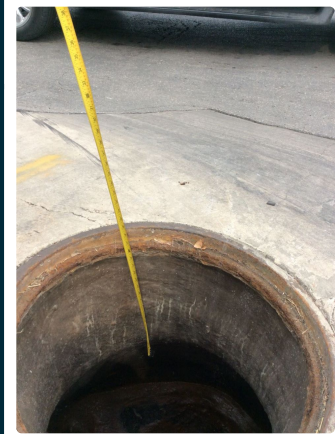
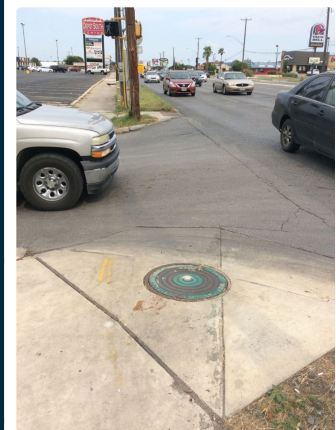
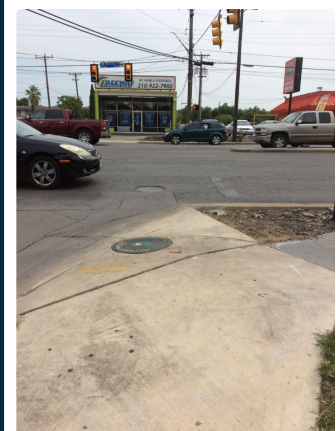
<b>OWNER</b>	<b>Utility</b>	SAWS	<b>Corridor</b>	SW MILITARY	<b>SITE PHOTOS</b>
	<b>Contact</b>	ANN PECHE	<b>ID</b>	7020	
<b>GENERAL INFO</b>	<b>Utility</b>	SANITARY SEWER			
	<b>Size and Material</b>	STANDARD MANHOLE, CAST IRON			
	<b>Accessible Route</b>	ASSET IS INSIDE ACCESSIBLE ROUTE			
	<b>Longitudinal or Crossing</b>	CROSSING			
	<b>Placement Relative to ROW</b>	INSIDE ROW			
<b>LOCATION</b>	<b>Sheet No.</b>	213			
	<b>Station</b>	955+35.70			
	<b>Offset</b>	-20.19			
	<b>Latitude</b>	+29.356868			
	<b>Longitude</b>	-98.49907			
<b>SUE</b>	<b>Level of Investigation Req'd</b>	NONE			
	<b>Test Hole No</b>	N/A			
	<b>Test Hole Depth</b>	N/A			
<b>RESOLUTION</b>	<b>Recommended Action</b>	MINIMIZE - PROTECT IN PLACE			
	<b>Estimated Resolution Date</b>				
	<b>Resolution Status</b>	UTILITY OWNER INFORMED OF UTILITY			
	<b>Comment</b>	Located in middle of curb ramp Top of cone to bottom of lid = 16"			
<b>Date Collected</b>		8/2/2018 2:58:29 PM		<b>Date Modified</b> 11/28/2018 6:59:12 AM
