Utility Conflict Report

OWNER	Utility	SAWS	Corridor	SW MILITARY	SITE PHOTOS	
	Contact	ANN PECHE	ID	7026		
GENERAL INFO	Utility	WATER

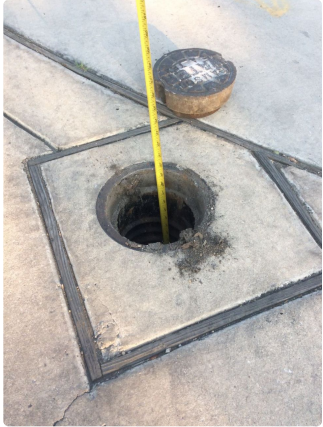
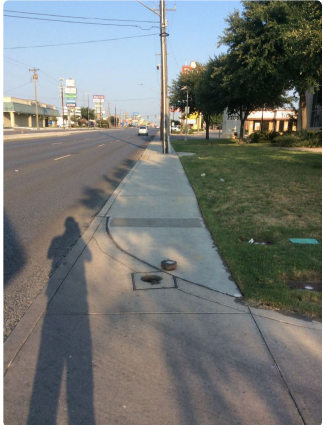
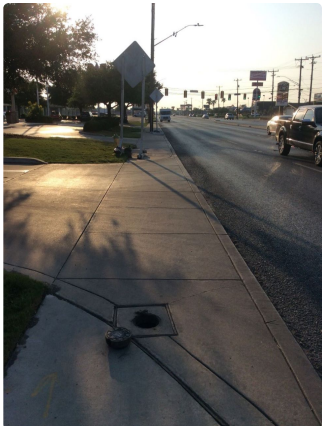
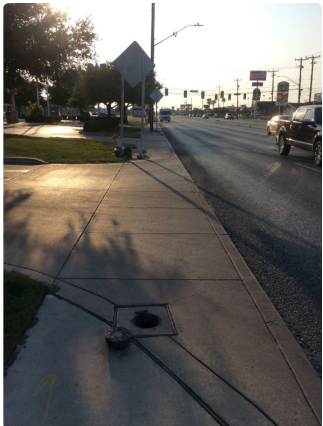
Size and Material	STANDARD WATER VALVE, CAST IRON				
	Accessible Route	ASSET IS INSIDE ACCESSIBLE ROUTE				
	Longitudinal or Crossing	CROSSING				
	Placement Relative to ROW	INSIDE ROW				
LOCATION	Sheet No.	213

Estimated Resolution Date					
	Resolution Status	UTILITY OWNER INFORMED OF UTILITY				
	Comment	Top of valve to surface = 4'-1" Lid thickness = 2" Back of curb to valve = 2'-9"				
Date Collected		8/3/2018 8:03:17 AM		Date Modified	11/28/2018 6:59:12 AM

Test Hole No	N/A				
	Test Hole Depth	N/A				
RESOLUTION	Recommended Action	MINIMIZE - PROTECT IN PLACE
