## Utility Conflict Report

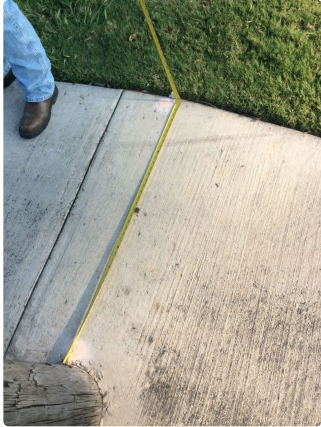
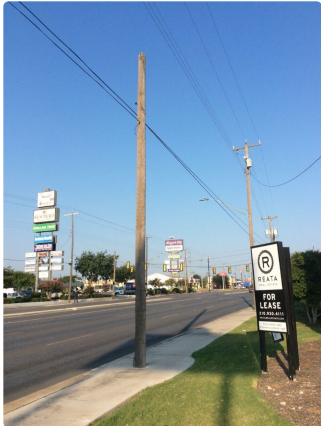
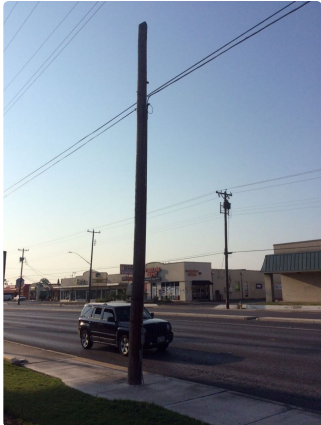
<b>OWNER</b>	<b>Utility</b>	CPS	<b>Corridor</b>	SW MILITARY	<b>SITE PHOTOS</b>		
	<b>Contact</b>	JAKE MARTINEZ	<b>ID</b>	7031			
<b>GENERAL INFO</b>	<b>Utility</b>	ELECTRIC					
	<b>Size and Material</b>	STANDARD POWER POLE, TIMBER					
	<b>Accessible Route</b>	ASSET IS INSIDE ACCESSIBLE ROUTE					
	<b>Longitudinal or Crossing</b>	CROSSING					
	<b>Placement Relative to ROW</b>	INSIDE ROW					
<b>LOCATION</b>	<b>Sheet No.</b>	212					
	<b>Station</b>	949+27.87					
	<b>Offset</b>	-17.1324					
	<b>Latitude</b>	+29.356780					
	<b>Longitude</b>	-98.50100					
<b>SUE</b>	<b>Level of Investigation Req'd</b>	NONE					
	<b>Test Hole No</b>	N/A					
	<b>Test Hole Depth</b>	N/A					
<b>RESOLUTION</b>	<b>Recommended Action</b>	NO CONFLICT					
	<b>Estimated Resolution Date</b>						
	<b>Resolution Status</b>	NO RESOLUTION WAS REQUIRED					
	<b>Comment</b>	Back of curb to pole = 2'-6" Pole to back of sidewalk = 3'-6" Pole diameter = 10" No pole ID
