## Utility Conflict Report

<b>OWNER</b>	<b>Utility</b>	SAWS	<b>Corridor</b>	SW MILITARY	<b>SITE PHOTOS</b>		
	<b>Contact</b>	ANN PECHE	<b>ID</b>	7034			
<b>GENERAL INFO</b>	<b>Utility</b>	SANITARY SEWER

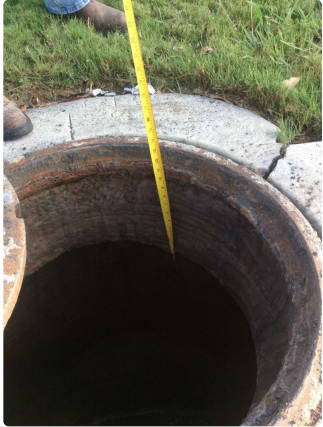
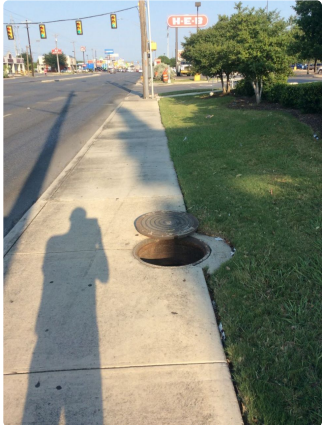
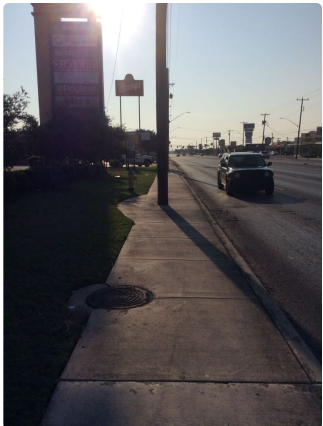
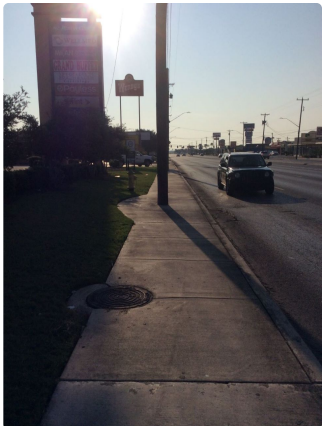
<b>Size and Material</b>	STANDARD MANHOLE, CAST IRON					
	<b>Accessible Route</b>	ASSET IS INSIDE ACCESSIBLE ROUTE					
	<b>Longitudinal or Crossing</b>	CROSSING					
	<b>Placement Relative to ROW</b>	INSIDE ROW					
<b>LOCATION</b>	<b>Sheet No.</b>	212

<b>Estimated Resolution Date</b>						
	<b>Resolution Status</b>	UTILITY OWNER INFORMED OF UTILITY					
	<b>Comment</b>	Bottom of cone to bottom of lid = 10" Back of curb to manhole = 3'-9"

<b>Test Hole No</b>	N/A					
	<b>Test Hole Depth</b>	N/A					
<b>RESOLUTION</b>	<b>Recommended Action</b>	MINIMIZE - PROTECT IN PLACE
