## Utility Conflict Report

<b>OWNER</b>	<b>Utility</b>	SAWS	<b>Corridor</b>	SW MILITARY	<b>SITE PHOTOS</b>		
	<b>Contact</b>	ANN PECHE	<b>ID</b>	7064			
<b>GENERAL INFO</b>	<b>Utility</b>	WATER

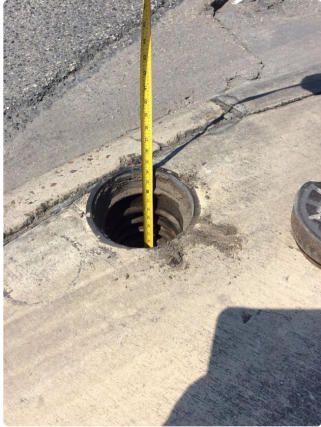
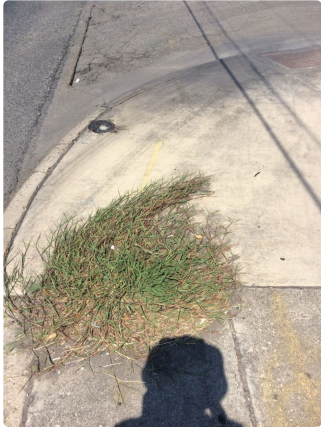
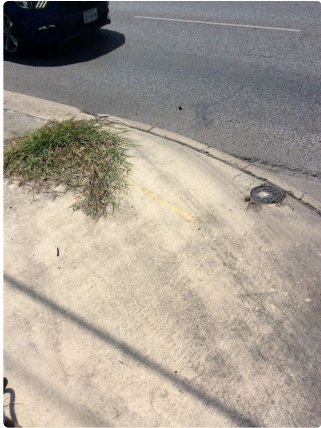
<b>Size and Material</b>	STANDARD WATER VALVE, CAST IRON					
	<b>Accessible Route</b>	ASSET IS INSIDE ACCESSIBLE ROUTE					
	<b>Longitudinal or Crossing</b>	CROSSING					
	<b>Placement Relative to ROW</b>	INSIDE ROW					
<b>LOCATION</b>	<b>Sheet No.</b>	203

<b>Test Hole No</b>	N/A					
	<b>Test Hole Depth</b>	N/A					
<b>RESOLUTION</b>	<b>Recommended Action</b>	NO CONFLICT					
	<b>Estimated Resolution Date</b>						
	<b>Resolution Status</b>	NO RESOLUTION WAS REQUIRED					
	<b>Comment</b>	Lid thickness = 2" Top of valve to surface = 2'-8" Valve adjacent to back of curb
