## Utility Conflict Report

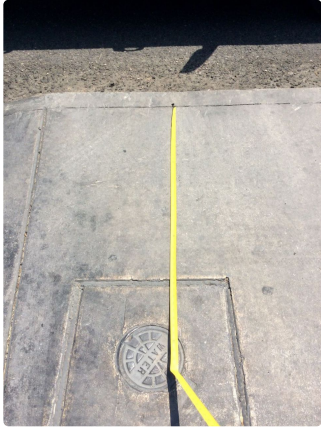
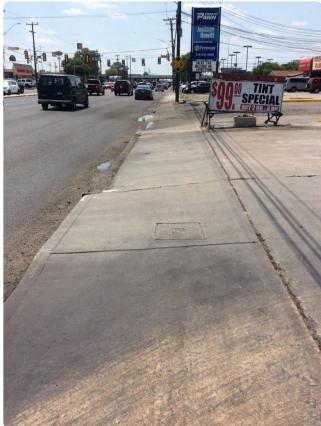
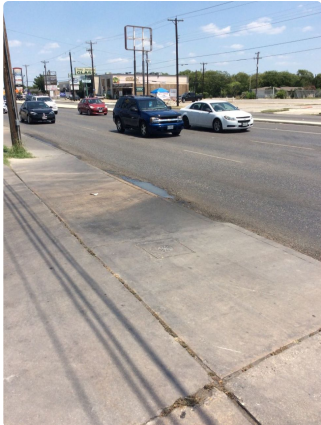
<b>OWNER</b>	<b>Utility</b>	SAWS	<b>Corridor</b>	SW MILITARY	<b>SITE PHOTOS</b>
	<b>Contact</b>	ANN PECHE	<b>ID</b>	7089	
<b>GENERAL INFO</b>	<b>Utility</b>	WATER			
	<b>Size and Material</b>	STANDARD WATER VALVE, CAST IRON			
	<b>Accessible Route</b>	ASSET IS INSIDE ACCESSIBLE ROUTE			
	<b>Longitudinal or Crossing</b>	CROSSING			
	<b>Placement Relative to ROW</b>	INSIDE ROW			
<b>LOCATION</b>	<b>Sheet No.</b>	199			
	<b>Station</b>	881+19.39			
	<b>Offset</b>	-17.34			
	<b>Latitude</b>	+29.356777			
	<b>Longitude</b>	-98.52239			
<b>SUE</b>	<b>Level of Investigation Req'd</b>	NONE			
	<b>Test Hole No</b>	N/A			
	<b>Test Hole Depth</b>	N/A			
<b>RESOLUTION</b>	<b>Recommended Action</b>	MINIMIZE - PROTECT IN PLACE			
	<b>Estimated Resolution Date</b>				
	<b>Resolution Status</b>	UTILITY OWNER INFORMED OF UTILITY			
	<b>Comment</b>	Unable to open lid Back of curb to valve = 3'-10"			
<b>Date Collected</b>		8/3/2018 2:44:31 PM		<b>Date Modified</b> 11/28/2018 6:59:12 AM
