Utility Conflict Report

| OWNER | Utility | SAWS | Corridor | SW MILITARY | SITE PHOTOS | | |
| GENERAL INFO | Utility | SANITARY SEWER | | | | | |

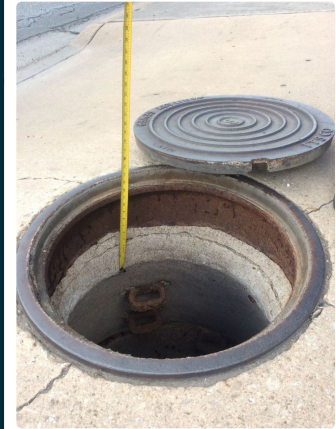
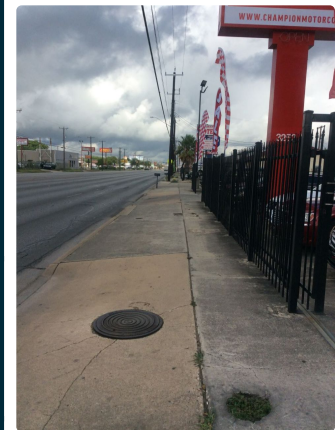
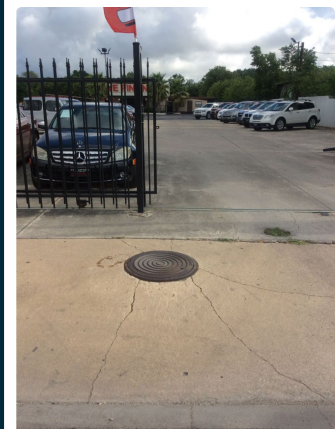
| | Size and Material | STANDARD MANHOLE, CAST IRON | | | | | |
| | Longitudinal or Crossing | CROSSING | | | | | |
| | Placement Relative to ROW | INSIDE ROW | | | | | |
| | Comment | Bottom of cone to surface = 1'-0" Bottom of cone to bottom of ring = 5" Manhole to fence = 4'-7" | | | | | |

| RESOLUTION | Recommended Action | MINIMIZE - PROTECT IN PLACE | | | | | |
