## Utility Conflict Report

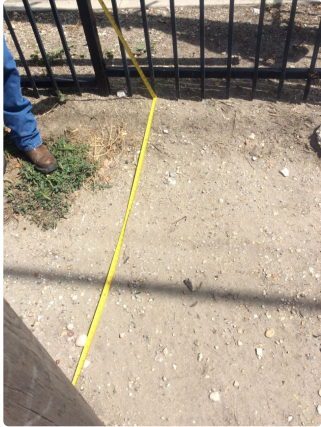
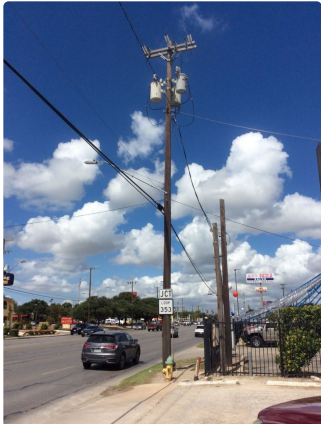
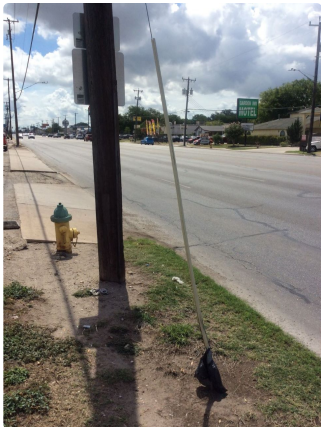
<b>OWNER</b>	<b>Utility</b>	CPS	<b>Corridor</b>	SW MILITARY	<b>SITE PHOTOS</b>		
	<b>Contact</b>	JAKE MARTINEZ	<b>ID</b>	7137			
<b>GENERAL INFO</b>	<b>Utility</b>	ELECTRIC					
	<b>Size and Material</b>	STANDARD POWER POLE, TIMBER					
	<b>Accessible Route</b>	ASSET IS INSIDE ACCESSIBLE ROUTE					
	<b>Longitudinal or Crossing</b>	CROSSING					
	<b>Placement Relative to ROW</b>	INSIDE ROW					
<b>LOCATION</b>	<b>Sheet No.</b>	178					
	<b>Station</b>	767+95.72					
	<b>Offset</b>	-17.0114					
	<b>Latitude</b>	+29.358234					
	<b>Longitude</b>	-98.55781					
<b>SUE</b>	<b>Level of Investigation Req'd</b>	NONE					
	<b>Test Hole No</b>	N/A					
	<b>Test Hole Depth</b>	N/A					
<b>RESOLUTION</b>	<b>Recommended Action</b>	NO CONFLICT					
	<b>Estimated Resolution Date</b>						
	<b>Resolution Status</b>	NO RESOLUTION WAS REQUIRED					
	<b>Comment</b>	Pole to fence = 4'-11" Pole diameter = 12" Back of curb to pole = 3'8" Pole to guy wire = 7'3"
