## Utility Conflict Report

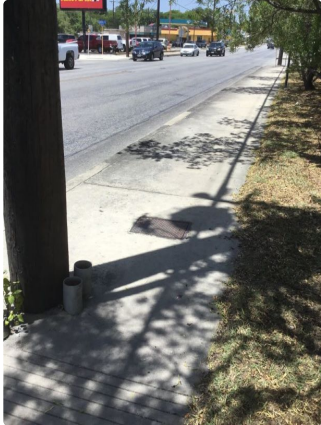
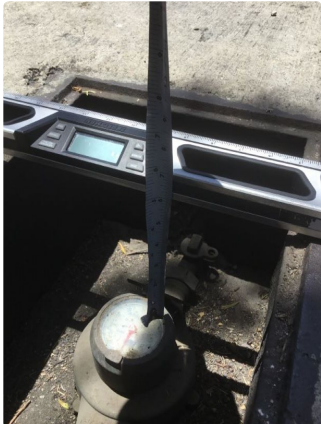
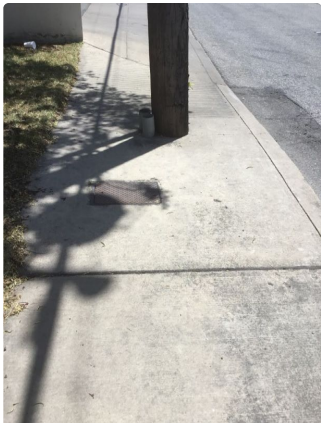
<b>OWNER</b>	<b>Utility</b>	SAWS	<b>Corridor</b>	NOGALITOS	<b>SITE PHOTOS</b>		
	<b>Contact</b>	NINA BITTLE	<b>ID</b>	3017			
<b>GENERAL INFO</b>	<b>Utility</b>	WATER					
	<b>Size and Material</b>	STANDARD WATER METER, CAST IRON					
	<b>Accessible Route</b>	ASSET IS INSIDE ACCESSIBLE ROUTE					
	<b>Longitudinal or Crossing</b>	CROSSING					
	<b>Placement Relative to ROW</b>	INSIDE ROW					
<b>LOCATION</b>	<b>Sheet No.</b>						
	<b>Station</b>	110+70.96					
	<b>Offset</b>	25.1602					
	<b>Latitude</b>	+29.388457					
	<b>Longitude</b>	-98.52212					
<b>SUE</b>	<b>Level of Investigation Req'd</b>	NONE					
	<b>Test Hole No</b>	N/A					
	<b>Test Hole Depth</b>	N/A					
<b>RESOLUTION</b>	<b>Recommended Action</b>	NO CONFLICT					
	<b>Estimated Resolution Date</b>	8/13/2018					
	<b>Resolution Status</b>	NO RESOLUTION WAS REQUIRED					
	<b>Comment</b>	Top of meter to surface = 6" Back of curb to meter = 3'-4" Sidewalk width = 6'-5"
