## Utility Conflict Report

<b>OWNER</b>	<b>Utility</b>	SAWS	<b>Corridor</b>	NOGALITOS	<b>SITE PHOTOS</b>		
	<b>Contact</b>	ANN PECHE	<b>ID</b>	4042			
<b>GENERAL INFO</b>	<b>Utility</b>	SANITARY SEWER

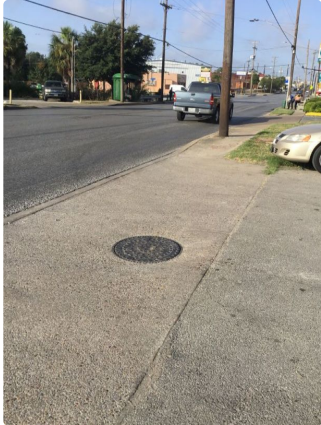
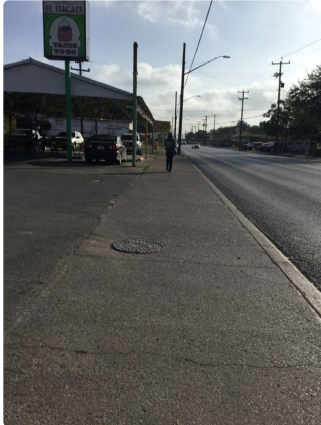
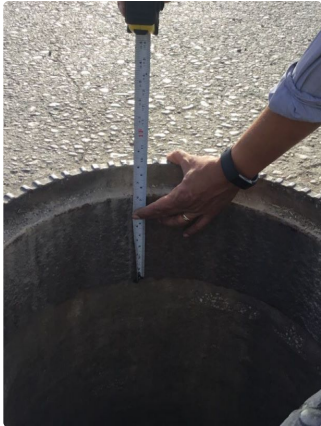
<b>Size and Material</b>	STANDARD MANHOLE, CAST IRON					
	<b>Accessible Route</b>	ASSET IS INSIDE ACCESSIBLE ROUTE					
	<b>Longitudinal or Crossing</b>	CROSSING					
	<b>Placement Relative to ROW</b>	INSIDE ROW					
<b>LOCATION</b>	<b>Sheet No.</b>	116

<b>Test Hole No</b>	N/A					
	<b>Test Hole Depth</b>	N/A					
<b>RESOLUTION</b>	<b>Recommended Action</b>	MINIMIZE - PROTECT IN PLACE					
	<b>Estimated Resolution Date</b>						
	<b>Resolution Status</b>	UTILITY OWNER INFORMED OF UTILITY					
	<b>Comment</b>	Back of curb to manhole = 4'-4" Bottom of cone to lid lip = 8" Lower rim 1"
