CITY OF SAN MARCOS ADA TRANSITION PLAN SIGNALIZED INTERSECTION ASSESSMENT AND COMPLIANCE REPORT

Location ID: 000000066 North-South Cross Street: IH 35 NBFR East-West Cross Street: CENTERPOINT RD Location Details

Date of Evaluation:
 6/25/2014

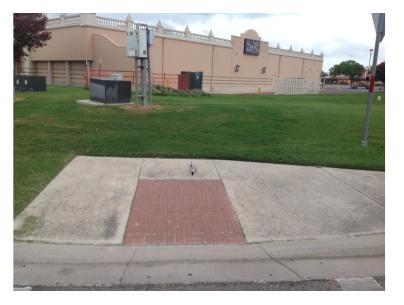
Location Photos

Ramp Elements	Curb ramp provided where an accessible route crosses a barrier: Is the slope of the ramp 1:12 or less:	YES
	Transition from curb ramp slope to roadway free from abrupt changes, no greater than 1:20:	NO
	Ramp is at least 36" wide:	YES
	Ramp surface is stable, firm, and slip resistant:	YES
Flare	Flares (if present) are 1:10 or less measured along the curb line; or If landing at top of ramp is not provided flares are 1:12 or less:	YES
Detectable Warning Surface	Curb ramp is located such that it does not project into roadway or parking aisles:	N/A
	Detectable warning is present:	YES
	DWS maintains correct geometric controls; 0.9" diameter domes, 0.2" in height, spaced at 2.35" and visually contracts adjacent ramp surface:	YES
Special Ramps	Ramp maintains defined edges parallel to direction of pedestrian travel; maintains 4'x4' turning pad contained in crosswalk; flared sides 24" segment on each side of ramp within crosswalk lines:	N/A
