CITY OF SAN MARCOS ADA TRANSITION PLAN SIGNALIZED INTERSECTION ASSESSMENT AND COMPLIANCE REPORT

Location ID: 0000000233
 North-South Cross Street: HUNTER RD
 East-West Cross Street: STAGECOACH TR

Date of Evaluation: 6/25/2014

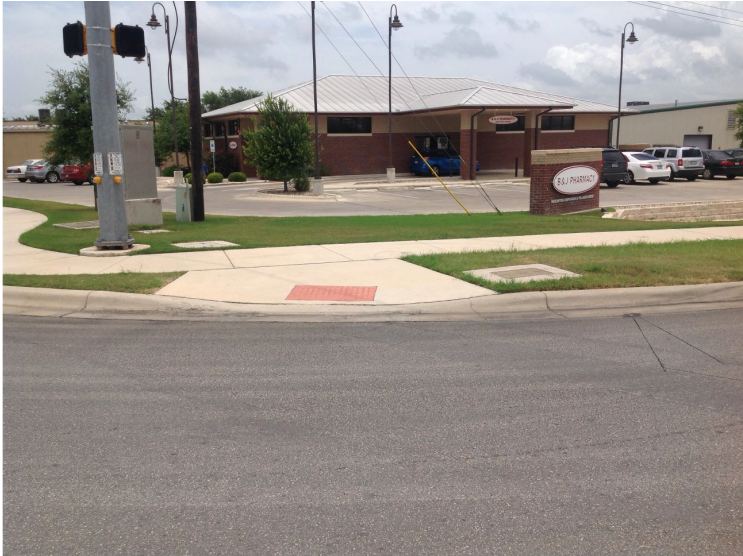
Location Photos

Ramp Elements	Curb ramp provided where an accessible route crosses a barrier:	YES
	Is the slope of the ramp 1:12 or less:	NO
	Transition from curb ramp slope to roadway free from abrupt changes, no greater than 1:20:	YES
	Ramp is at least 36" wide:	YES
	Ramp surface is stable, firm, and slip resistant:	YES
Flare	Flares (if present) are 1:10 or less measured along the curb line; or If landing at top of ramp is not provided flares are 1:12 or less:	YES
Detectable Warning Surface	Curb ramp is located such that it does not project into roadway or parking aisles:	N/A
	Detectable warning is present:	YES
	DWS maintains correct geometric controls; 0.9" diameter domes, 0.2" in height, spaced at 2.35" and visually contracts adjacent ramp surface:	YES
Special Ramps	Ramp maintains defined edges parallel to direction of pedestrian travel; maintains 4'x4' turning pad contained in crosswalk; flared sides 24" segment on each side of ramp within crosswalk lines:	YES
