**CITY OF SAN MARCOS  
ADA TRANSITION PLAN  
SIGNALIZED INTERSECTION ASSESSMENT  
AND COMPLIANCE REPORT**

Location ID: 0000000268  
 North-South Cross Street: SAN ANTONIO ST  
 East-West Cross Street: GUADALUPE ST

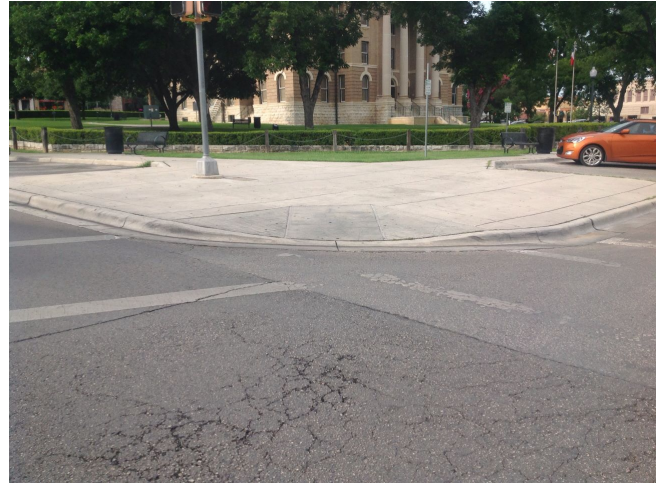
<b>Ramp Elements</b>	Curb ramp provided where an accessible route crosses a barrier:	YES
	Is the slope of the ramp 1:12 or less:	NO
	Transition from curb ramp slope to roadway free from abrupt changes, no greater than 1:20:	YES
	Ramp is at least 36" wide:	YES
	Ramp surface is stable, firm, and slip resistant:	YES
<b>Flare</b>	Flares (if present) are 1:10 or less measured along the curb line; or If landing at top of ramp is not provided flares are 1:12 or less:	YES
<b>Detectable Warning Surface</b>	Curb ramp is located such that it does not project into roadway or parking aisles:	YES
	Detectable warning is present:	NO
	DWS maintains correct geometric controls; 0.9" diameter domes, 0.2" in height, spaced at 2.35" and visually contracts adjacent ramp surface:	NO
<b>Special Ramps</b>	Ramp maintains defined edges parallel to direction of pedestrian travel; maintains 4'x4' turning pad contained in crosswalk; flared sides 24" segment on each side of ramp within crosswalk lines:	NO

Ramp is located so they will not be obstructed by parked vehicles:	YES
	Ramp wholly contained within the crosswalk lines:	YES
	If island is present; Island maintains a cut through at street level or ramps on either side with landing between them:	N/A
