Utility Conflict Report

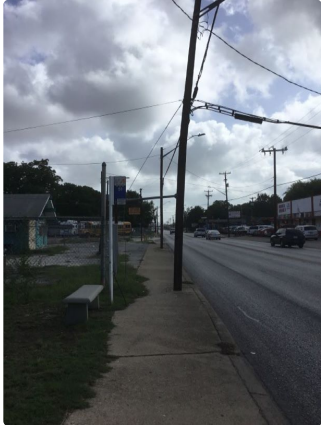
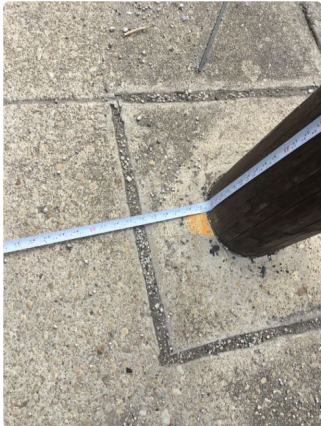
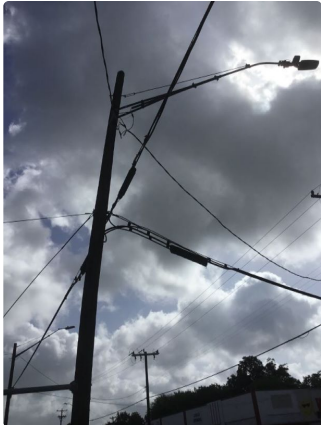
OWNER	Utility	CPS	Corridor	NOGALITOS	SITE PHOTOS		
	Contact	JAKE MARTINEZ	ID	3026			
GENERAL INFO	Utility	ELECTRIC					
	Size and Material	STANDARD POWER POLE, TIMBER					
	Accessible Route	ASSET IS INSIDE ACCESSIBLE ROUTE					
	Longitudinal or Crossing	CROSSING					
	Placement Relative to ROW	INSIDE ROW					
LOCATION	Sheet No.						
	Station	123+89.67					
	Offset	-23.8689					
	Latitude	+29.391397					
	Longitude	-98.51970					
SUE	Level of Investigation Req'd	NONE					
	Test Hole No	N/A					
	Test Hole Depth	N/A					
RESOLUTION	Recommended Action	NO CONFLICT					
	Estimated Resolution Date	8/13/2018					
	Resolution Status	NO RESOLUTION WAS REQUIRED

Comment	Pole ID: LW 59189; PL 467524. Pole to back of sidewalk = 4'-0" Guy wire vertical clearance = 7'-9" Guy wire to pole = 5'-0" Pole to fence = 6'-0" Adjacent to VIA bus stop no. 61897					
Date Collected		7/10/2018 10:01:54 AM		Date Modified		8/14/2018 4:38:26 PM
