Utility Conflict Report

OWNER	Utility	SAWS	Corridor	SW MILITARY	SITE PHOTOS	
	Contact	ANN PECHE	ID	3092		
GENERAL INFO	Utility	SANITARY SEWER

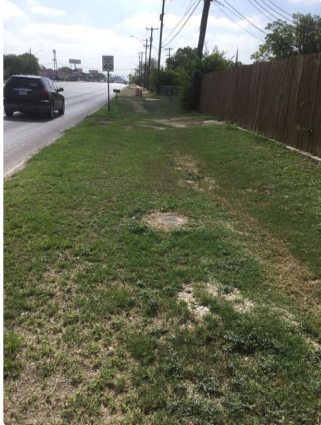
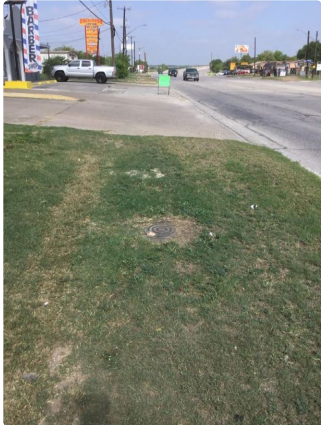
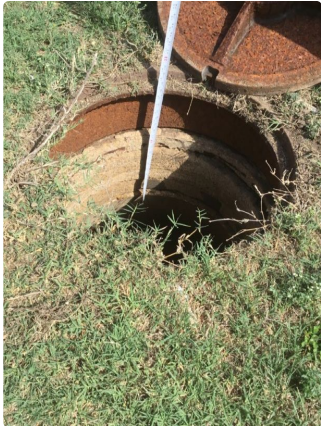
Size and Material	STANDARD MANHOLE, CAST IRON				
	Accessible Route	ASSET IS INSIDE ACCESSIBLE ROUTE				
	Longitudinal or Crossing	CROSSING				
	Placement Relative to ROW	INSIDE ROW				
LOCATION	Sheet No.	123

Station	513+90.96				
	Offset	20.2407				
	Latitude	+29.358708				
	Longitude	-98.56531				
SUE	Level of Investigation Req'd	NONE				
	Test Hole No	N/A				
	Test Hole Depth	N/A				
RESOLUTION	Recommended Action	NO CONFLICT

Estimated Resolution Date	8/14/2018				
	Resolution Status	NO RESOLUTION WAS REQUIRED				
	Comment	Back of curb to sewer manhole = 6'-2" Edge of parking lot to sewer manhole = 8'-5" Bottom of cone to surface = 2'-8" Lid thickness = 1 1/2"				
	Date Collected	7/19/2018 10:22:45 AM	Date Modified	11/28/2018 6:59:12 AM
