Utility Conflict Report

OWNER	Utility	SAWS	Corridor	SW MILITARY	SITE PHOTOS	
	Contact	ANN PECHE	ID	4175		
GENERAL INFO	Utility	SANITARY SEWER

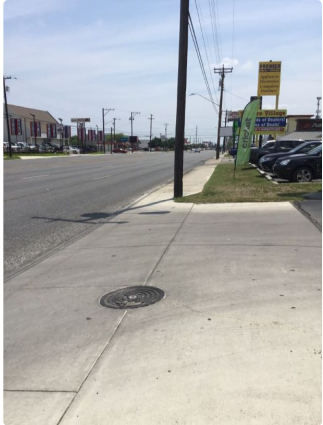
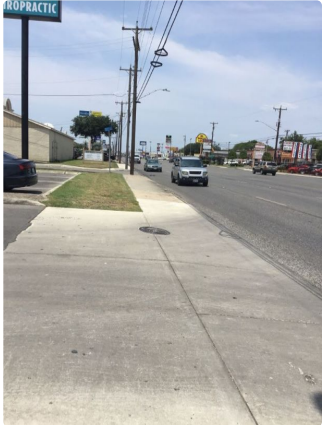
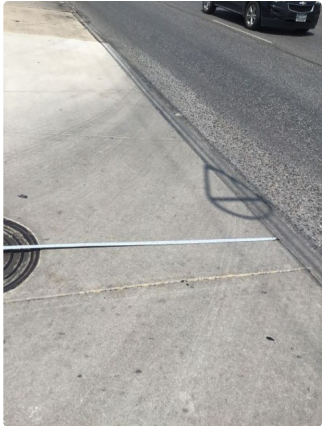
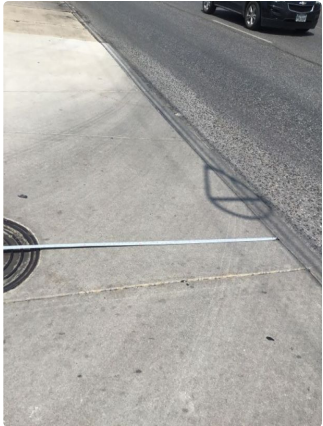
Size and Material	STANDARD MANHOLE, CAST IRON				
	Accessible Route	ASSET IS INSIDE ACCESSIBLE ROUTE				
	Longitudinal or Crossing	CROSSING				
	Placement Relative to ROW	INSIDE ROW				
LOCATION	Sheet No.

Estimated Resolution Date					
	Resolution Status	NO RESOLUTION WAS REQUIRED				
	Comment	Back of curb to manhole = 4'-8.5" Sidewalk width = 6'-0" Unable to open manhole				
Date Collected		8/2/2018 12:41:16 PM	Date Modified		11/28/2018 6:59:12 AM

Test Hole No	N/A				
	Test Hole Depth	N/A				
RESOLUTION	Recommended Action	NO CONFLICT
