## Utility Conflict Report

<b>OWNER</b>	<b>Utility</b>	SAWS	<b>Corridor</b>	SW MILITARY	<b>SITE PHOTOS</b>	
	<b>Contact</b>	ANN PECHE	<b>ID</b>	4214		
<b>GENERAL INFO</b>	<b>Utility</b>	WATER

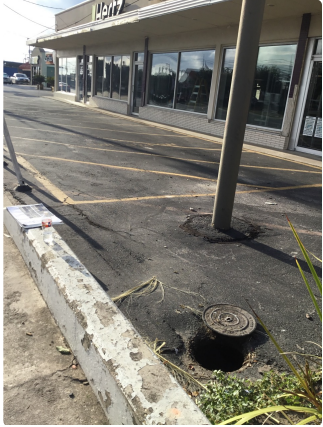
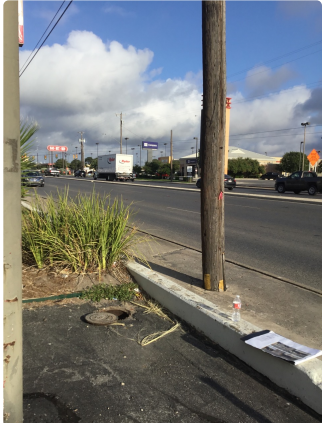
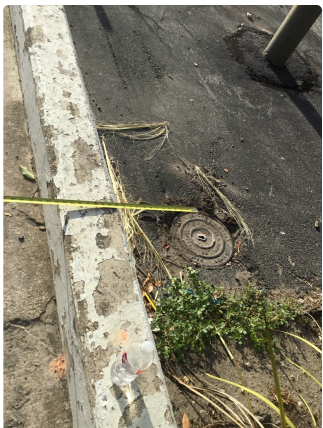
<b>Size and Material</b>	STANDARD WATER METER, STEEL				
	<b>Accessible Route</b>	ASSET IS OUTSIDE ACCESSIBLE ROUTE				
	<b>Longitudinal or Crossing</b>	CROSSING				
	<b>Placement Relative to ROW</b>	INSIDE ROW				
<b>LOCATION</b>	<b>Sheet No.</b>	166

<b>Estimated Resolution Date</b>					
	<b>Resolution Status</b>	NO RESOLUTION WAS REQUIRED				
	<b>Comment</b>	Meter filled with dirt Top of meter to surface = 10" Back of wall to meter = 1'-4" Lid flange thickness = 3/8" Overall lid thickness = 1 5/8"

<b>Test Hole No</b>	N/A				
	<b>Test Hole Depth</b>	N/A				
<b>RESOLUTION</b>	<b>Recommended Action</b>	NO CONFLICT
