Utility Conflict Report

| OWNER | Utility | SAWS | Corridor | SW MILITARY | SITE PHOTOS | |
| | Contact | ANN PECHE | ID | 7083 | | |

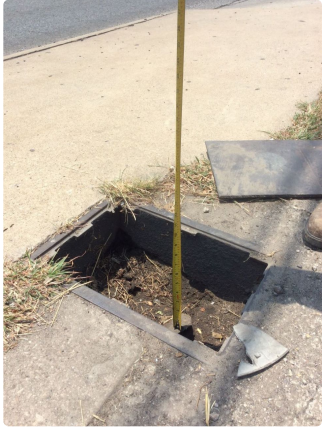
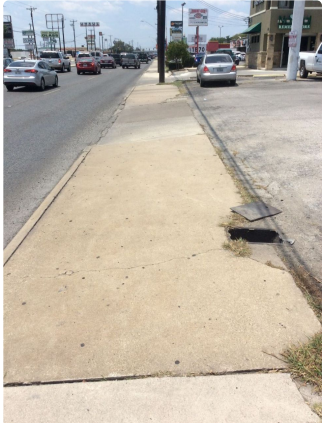
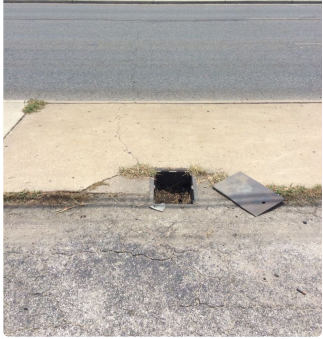
| | Size and Material | STANDARD WATER METER, STEEL | | | | |
| | Accessible Route | ASSET IS INSIDE ACCESSIBLE ROUTE | | | | |
| | Longitudinal or Crossing | CROSSING | | | | |
| | Placement Relative to ROW | INSIDE ROW | | | | |
| | Comment | Meter adjacent to back of sidewalk Top of meter to surface = 6" Lid thickness = 3/8" | | | | |

| RESOLUTION | Recommended Action | MINIMIZE - PROTECT IN PLACE | | | | |
| | Resolution Status | UTILITY OWNER INFORMED OF UTILITY | | | | |
