Utility Conflict Report

OWNER	Utility	CPS	Corridor	NOGALITOS	SITE PHOTOS		
	Contact	JAKE MARTINEZ	ID	3065			
GENERAL INFO	Utility	ELECTRIC

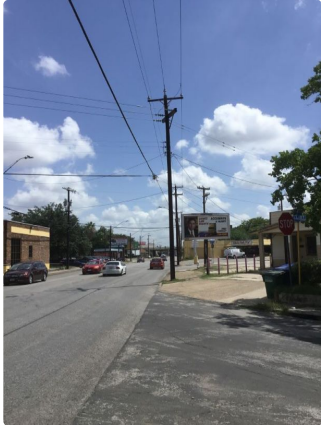
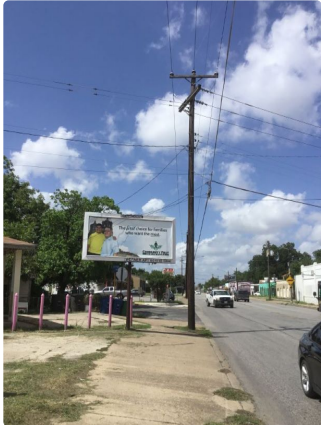
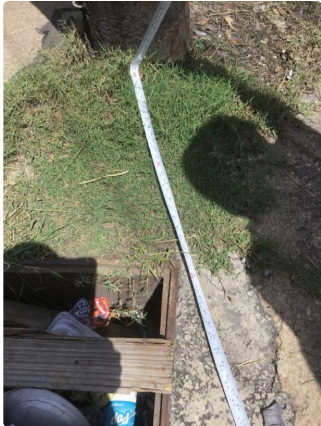
Size and Material	STANDARD POWER POLE, TIMBER					
	Accessible Route	ASSET IS INSIDE ACCESSIBLE ROUTE					
	Longitudinal or Crossing	CROSSING					
	Placement Relative to ROW	INSIDE ROW					
LOCATION	Sheet No.	86

Test Hole No	N/A					
	Test Hole Depth	N/A					
RESOLUTION	Recommended Action	NO CONFLICT					
	Estimated Resolution Date						
	Resolution Status	NO RESOLUTION WAS REQUIRED					
	Comment	Pole to back of sidewalk = 6'-0" Pole to water valve (no lid) = 1'-10" No pole ID FO CATV cable					
Date Collected		7/11/2018 11:35:49 AM		Date Modified		8/15/2018 12:40:04 PM
