Utility Conflict Report

OWNER	Utility	CPS	Corridor	NOGALITOS	SITE PHOTOS	
	Contact	JAKE MARTINEZ	ID	4052		
GENERAL INFO	Utility	ELECTRIC

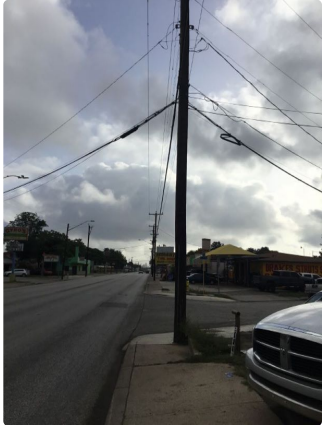
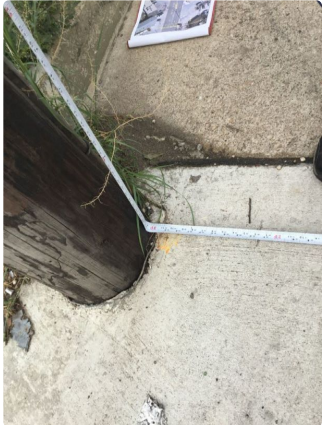
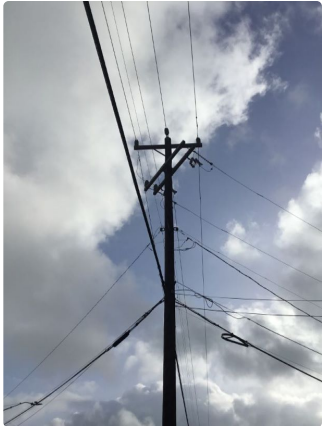
Size and Material	STANDARD POWER POLE, TIMBER				
	Accessible Route	ASSET IS INSIDE ACCESSIBLE ROUTE				
	Longitudinal or Crossing	CROSSING				
	Placement Relative to ROW	INSIDE ROW				
LOCATION	Sheet No.	77

Station	119+79.44				
	Offset	24.65				
	Latitude	+29.390386				
	Longitude	-98.52036				
SUE	Level of Investigation Req'd	NONE

Test Hole No	N/A				
	Test Hole Depth	N/A				
RESOLUTION	Recommended Action	MINIMIZE - PROTECT IN PLACE				
	Estimated Resolution Date					
	Resolution Status	UTILITY OWNER INFORMED OF UTILITY				
	Comment	Pole ID: R14011 Pole to back of curb = 3'-0"				
Date Collected		7/10/2018 8:25:28 AM		Date Modified 9/13/2018 2:01:26 PM
