CITY OF SAN MARCOS ADA TRANSITION PLAN SIGNALIZED INTERSECTION ASSESSMENT AND COMPLIANCE REPORT

Location ID: 000000068
 North-South Cross Street: IH 35 NBFR
 East-West Cross Street: CENTERPOINT RD

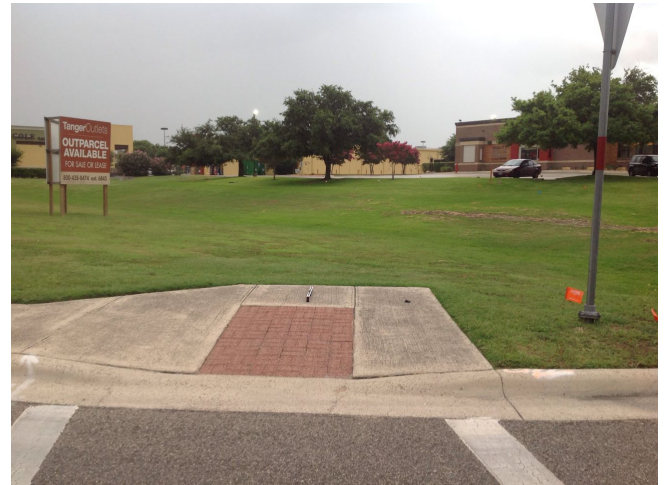
Signalized Intersection: YES
 Accessible Features: YES
 Pedestrian Features Accessible: YES

Ramp Elements	Curb ramp provided where an accessible route crosses a barrier:	YES
	Is the slope of the ramp 1:12 or less:	YES
	Transition from curb ramp slope to roadway free from abrupt changes, no greater than 1:20:	YES
	Ramp is at least 36" wide:	YES
	Ramp surface is stable, firm, and slip resistant:	YES
Flare	Flares (if present) are 1:10 or less measured along the curb line; or If landing at top of ramp is not provided flares are 1:12 or less:	YES
Detectable Warning Surface	Curb ramp is located such that it does not project into roadway or parking aisles:	N/A
	Detectable warning is present:	YES
	DWS maintains correct geometric controls; 0.9" diameter domes, 0.2" in height, spaced at 2.35" and visually contracts adjacent ramp surface:	YES
Special Ramps	Ramp maintains defined edges parallel to direction of pedestrian travel; maintains 4'x4' turning pad contained in crosswalk; flared sides 24" segment on each side of ramp within crosswalk lines:	N/A

Ramp is located so they will not be obstructed by parked vehicles:	N/A
	Ramp wholly contained within the crosswalk lines:	YES
	If island is present; Island maintains a cut through at street level or ramps on either side with landing between them:	N/A
