CITY OF SAN MARCOS ADA TRANSITION PLAN SIGNALIZED INTERSECTION ASSESSMENT AND COMPLIANCE REPORT

Location ID: 000000079
 North-South Cross Street: SH 123
 East-West Cross Street: BROADWAY ST

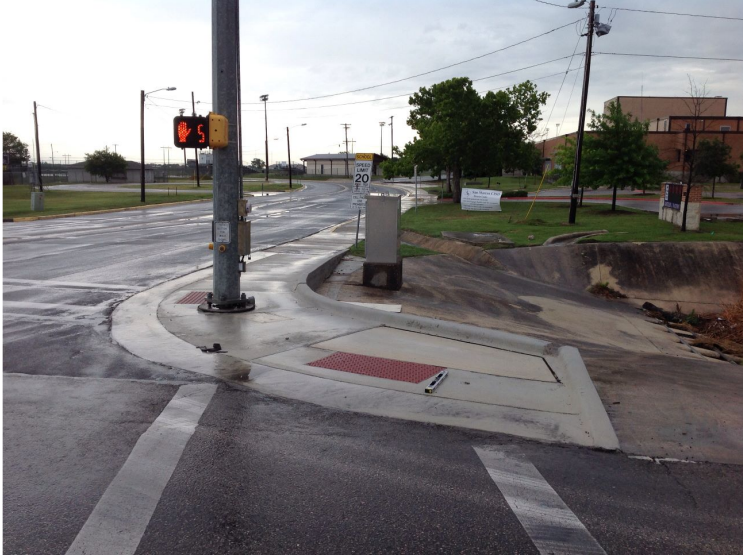
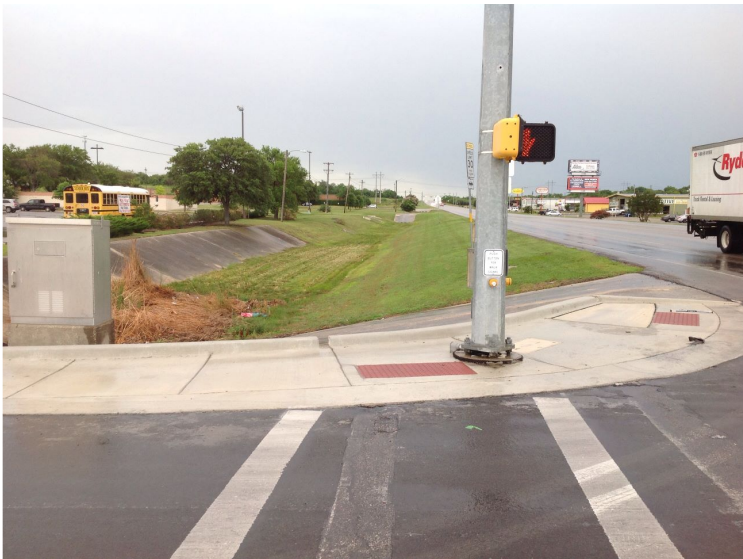
Location Photos

Ramp Elements	Curb ramp provided where an accessible route crosses a barrier:	YES
	Is the slope of the ramp 1:12 or less:	YES
	Transition from curb ramp slope to roadway free from abrupt changes, no greater than 1:20:	NO
	Ramp is at least 36" wide:	YES
	Ramp surface is stable, firm, and slip resistant:	YES
Flare	Flares (if present) are 1:10 or less measured along the curb line; or If landing at top of ramp is not provided flares are 1:12 or less:	NO
Detectable Warning Surface	Curb ramp is located such that it does not project into roadway or parking aisles:	N/A
	Detectable warning is present:	YES
	DWS maintains correct geometric controls; 0.9" diameter domes, 0.2" in height, spaced at 2.35" and visually contracts adjacent ramp surface:	YES
Special Ramps	Ramp maintains defined edges parallel to direction of pedestrian travel; maintains 4'x4' turning pad contained in crosswalk; flared sides 24" segment on each side of ramp within crosswalk lines:	N/A
