CITY OF SAN MARCOS ADA TRANSITION PLAN SIGNALIZED INTERSECTION ASSESSMENT AND COMPLIANCE REPORT

Location ID: 000000081
 North-South Cross Street: SH 123
 East-West Cross Street: HAYS ST

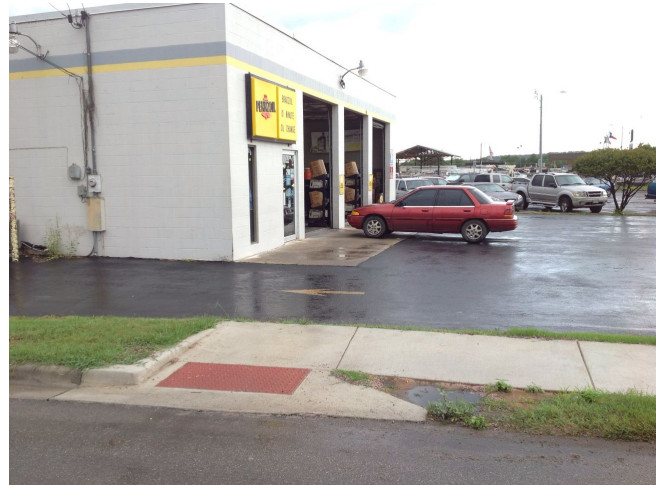
Signalized Intersection: YES
 Accessible Features: NO
 Pedestrian Features Accessible: NO

Ramp Elements	Curb ramp provided where an accessible route crosses a barrier:	YES
	Is the slope of the ramp 1:12 or less:	YES
	Transition from curb ramp slope to roadway free from abrupt changes, no greater than 1:20:	YES
	Ramp is at least 36" wide:	YES
	Ramp surface is stable, firm, and slip resistant:	YES
Flare	Flares (if present) are 1:10 or less measured along the curb line; or If landing at top of ramp is not provided flares are 1:12 or less:	YES
Detectable Warning Surface	Curb ramp is located such that it does not project into roadway or parking aisles:	N/A
	Detectable warning is present:	YES
	DWS maintains correct geometric controls; 0.9" diameter domes, 0.2" in height, spaced at 2.35" and visually contracts adjacent ramp surface:	YES
Special Ramps	Ramp maintains defined edges parallel to direction of pedestrian travel; maintains 4'x4' turning pad contained in crosswalk; flared sides 24" segment on each side of ramp within crosswalk lines:	N/A

Ramp is located so they will not be obstructed by parked vehicles:	N/A
	Ramp wholly contained within the crosswalk lines:	N/A
	If island is present; Island maintains a cut through at street level or ramps on either side with landing between them:	N/A
